# Access Compliance Report

## Public Rights-of-Way

### (Curb Ramps)

| Intersection ID: 43075 | Main Street: SCOTT_AV | Cross Street: ROMANY_RD | Location: W |

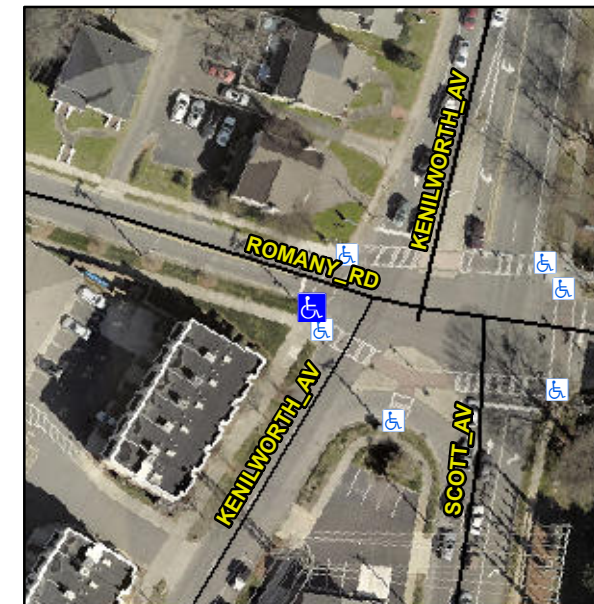
| ADA ID: CF49944F3298 | Ramp Type: Perp | Initial Pass/Fail: Fail | Overall Compliance: No |

**N/A**

| Compliance | Description | Data | Compliance | Description | Data |
|---|---|---|---|---|---|
| N/A | Ramp Length (in) | 94.0 | Yes | Ramp Slope (%) | 7.4 |
| No | Ramp Width (in) | 47.0 | No | Ramp XSlope (%) | 5.4 |

**Remove & Replace Entire Ramp.**

**R304.5.1, R304.5.3**

Total Cost: \$ 1850.00
