Access Compliance Report

Public Rights-of-Way

(Curb Ramps)

Intersection ID: N/A	Main Street: CRESSWIND BV	Cross Street: TREESDALE LN	Location: S
ADA ID: CF50AC0041EB	Ramp Type: Perp	Initial Pass/Fail: Fail	Overall Compliance: No
Codes/Mitigation Info/Possible Solution		Field Measurements/Component Compliance	
Severity Score: 13.75

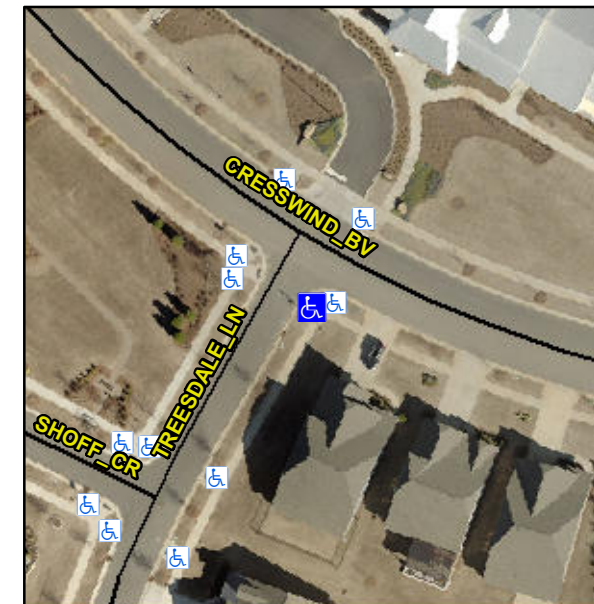
Compliance	Description	Data	Compliance	Description	Data
N/A	Ramp Length (in)	100.0	No	Ramp Slope (%)	9.1
Yes	Ramp Width (in)	48.0	No	Ramp XSlope (%)	4.5
N/A	Flare Type LT	N/A	N/A	Flare Type RT	N/A
N/A	Flare Slope LT (%)	N/A	N/A	Flare Slope RT (%)	N/A
N/A	Flare Traversable LT?	No	N/A	Flare Traversable RT?	No
N/A	Landing Length (in)	N/A	N/A	DWS Provided?	N/A
N/A	Landing Width (in)	N/A	N/A	DWS Contrast?	N/A
N/A	Landing Slope (%)	N/A	N/A	DWS Length (in)	N/A
N/A	Landing X Slope (%)	N/A	N/A	DWS Full Width?	N/A
N/A	Landing Curb? (Y/N)	N/A	N/A	DWS Offset (in)	N/A
N/A	Shared Landing?	N/A			
N/A	Gutter Ponding?	N/A	N/A	Gutter Slope (%)	N/A
N/A	Gutter Lip Ht (in)	1.0	N/A	Gutter X Slope (%)	N/A
N/A	Painted X Walk1?	No	N/A	Painted X Walk2?	N/A
	X Walk 1 Direction	To NW		X Walk 2 Direction	N/A
N/A	X Walk 1 Width (in)	N/A	N/A	X Walk 2 Width (in)	N/A
	X Walk 1 Slope (%)	2.7		X Walk 2 Slope (%)	N/A
	X Walk 1 X Slope (%)	2.1		X Walk 2 X Slope (%)	N/A

N/A	Ramp inside XWalk1?	N/A	N/A	Ramp inside XWalk2?	N/A
	Road Slope (%)	N/A	N/A	Clear Space?	N/A
	Road X Slope (%)	N/A	N/A	Clear Space to XWalk (in)	N/A
N/A	Any Obstructions?	N/A	N/A	Storm Grate/Utility Hazard?	N/A
	Obstruction Type			Storm Grate/Utility Type	
		N/A			N/A
			Yes	Surface Condition? (G/P)	Good

Possible Solutions:

Remove & Replace Entire Ramp.

R304.2.2, R304.5.3

Total Cost: \$ 1850.00
