Access Compliance Report

Public Rights-of-Way

(Curb Ramps)

Intersection ID: 2729	Main Street: FAIRVISTA_DR	Cross Street: FAIRWAY_POINT_DR	Location: NW
ADA ID: CF544487512A	Ramp Type: PerpDiag	Initial Pass/Fail: Fail	Overall Compliance: No
		Severity Score: 10

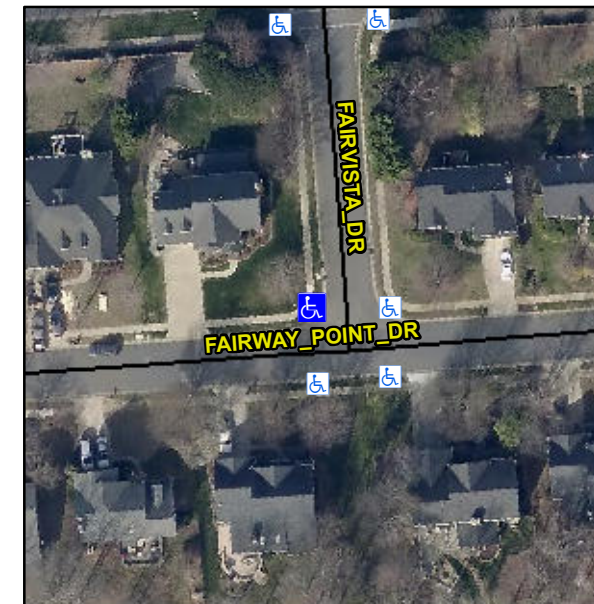
Not Found, R304.5.1, R304.5.3

Compliance	Description	Data	Compliance	Description	Data
N/A	Ramp Length (in)	50.0	Yes	Ramp Slope (%)	8.0
No	Ramp Width (in)	36.0	No	Ramp XSlope (%)	2.5
N/A	Flare Type LT	N/A	N/A	Flare Type RT	N/A
N/A	Flare Slope LT (%)	N/A	N/A	Flare Slope RT (%)	N/A
N/A	Flare Traversable LT?	N/A	N/A	Flare Traversable RT?	N/A
N/A	Landing Length (in)	N/A	N/A	DWS Provided?	N/A
N/A	Landing Width (in)	N/A	N/A	DWS Contrast?	N/A
N/A	Landing Slope (%)	N/A	N/A	DWS Length (in)	N/A
N/A	Landing X Slope (%)	N/A	N/A	DWS Full Width?	N/A
N/A	Landing Curb? (Y/N)	N/A	N/A	DWS Offset (in)	N/A
N/A	Shared Landing?	N/A			
N/A	Gutter Ponding?	Yes	N/A	Gutter Slope (%)	N/A
N/A	Gutter Lip Ht (in)	N/A	N/A	Gutter X Slope (%)	N/A
N/A	Painted X Walk1?	No	N/A	Painted X Walk2?	No
	X Walk 1 Direction	To S		X Walk 2 Direction	To E
N/A	X Walk 1 Width (in)	N/A	N/A	X Walk 2 Width (in)	N/A
	X Walk 1 Slope (%)	5.9		X Walk 2 Slope (%)	0.7
	X Walk 1 X Slope (%)	1.5		X Walk 2 X Slope (%)	1.4

N/A	Ramp inside XWalk1?	N/A	N/A	Ramp inside XWalk2?	N/A
	Road Slope (%)	2.0	N/A	Clear Space?	N/A
	Road X Slope (%)	3.8	N/A	Clear Space to XWalk (in)	N/A
N/A	Any Obstructions?	N/A	N/A	Storm Grate/Utility Hazard?	N/A
	Obstruction Type			Storm Grate/Utility Type	
		N/A			N/A
		Yes		Surface Condition? (G/P)	Good

Remove & Replace Curb Ramp With Two New Directional Ramps or Equivalent.
