# Access Compliance Report

## Public Rights-of-Way (Curb Ramps)

Intersection ID: 46544	Main Street: STEELE_CREEK_RD	Cross Street: VIRKLER_DR	Location: SE
ADA ID: CF5A4642A03E	Ramp Type: BlendTrans1	Initial Pass/Fail: Fail	Overall Compliance: No
Severity Score: 1.25			
Codes/Mitigation Info/Possible Solution		Field Measurements/Component Compliance

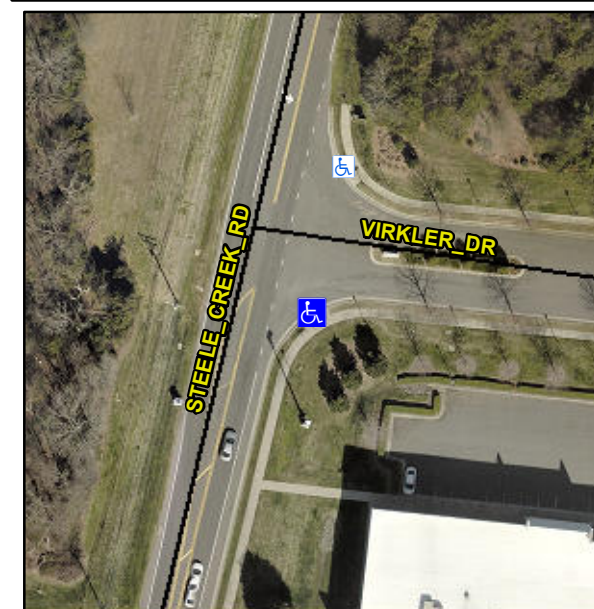
**LT RP < 5%**

**R304.5.3**

Compliance	Description	Data	Compliance	Description	Data
N/A	Ramp Length (in)	49.0	Yes	BlendTrans Slope (%)	2.1
Yes	Ramp Width (in)	53.0	No	BlendTrans XSlope (%)	2.3
N/A	Flare Type LT	N/A	N/A	Flare Type RT	N/A
N/A	Flare Slope LT (%)	N/A	N/A	Flare Slope RT (%)	N/A
N/A	Flare Traversable LT?	N/A	N/A	Flare Traversable RT?	N/A
N/A	Landing Length (in)	N/A	N/A	DWS Provided?	N/A
N/A	Landing Width (in)	N/A	N/A	DWS Contrast?	N/A
N/A	Landing Slope (%)	N/A	N/A	DWS Length (in)	N/A
N/A	Landing X Slope (%)	N/A	N/A	DWS Full Width?	N/A
N/A	Landing Curb? (Y/N)	N/A	N/A	DWS Offset (in)	N/A
N/A	Shared Landing?	N/A			
N/A	Gutter Ponding?	N/A	N/A	Gutter Slope (%)	N/A
N/A	Gutter Lip Ht (in)	N/A	N/A	Gutter X Slope (%)	N/A
N/A	Painted X Walk1?	No	N/A	Painted X Walk2?	No
	X Walk 1 Direction	To NE		X Walk 2 Direction	To NW
	X Walk 1 Width (in)	N/A		X Walk 2 Width (in)	N/A
	X Walk 1 Slope (%)	1.2		X Walk 2 Slope (%)	2.0
	X Walk 1 X Slope (%)	2.1		X Walk 2 X Slope (%)	0.7

N/A	Ramp inside XWalk1?	N/A	N/A	Ramp inside XWalk2?	N/A
	Road Slope (%)	0.9		Clear Space?	N/A
	Road X Slope (%)	0.8	N/A	Clear Space to XWalk (in)	N/A
N/A	Any Obstructions?	N/A	N/A	Storm Grate/Utility Hazard?	N/A
	Obstruction Type			Storm Grate/Utility Type	
		N/A			N/A
			Yes	Surface Condition? (G/P)	Good
			N/A	Curb Slope (%)	5.0

**Remove & Replace Curb Ramp With Two New Directional Ramps or Equivalent.**

Total Cost: \$ 3200.00
