# Access Compliance Report

## Public Rights-of-Way

| Intersection ID: 30323 | Main Street: SHINKANSEN_DR | Cross Street: STOURBRIDGE_LION_DR | Location: E |
| ADA ID: CF5EC02F2356 | Ramp Type: BlendTrans1 | Initial Pass/Fail: Pass | Overall Compliance: No |

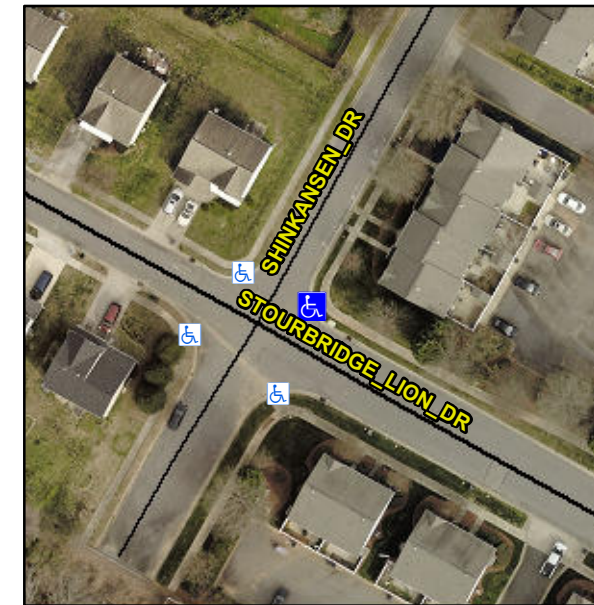
**Not Found, R304.2.2-Perp, R304.3.2-Para, R305**

| Compliance | Description | Data | Compliance | Description | Data |
|---|---|---|---|---|---|
| Yes | Landing Length (in) | 60.5 | No | DWS Provided? | No |
| No | Landing Slope (%) | 2.8 | N/A | DWS Length (in) | N/A |
| | | | No | Curb Slope (%) | 17.4 |

**Remove & Replace Curb Ramp With Two New Directional Ramps or Equivalent.**

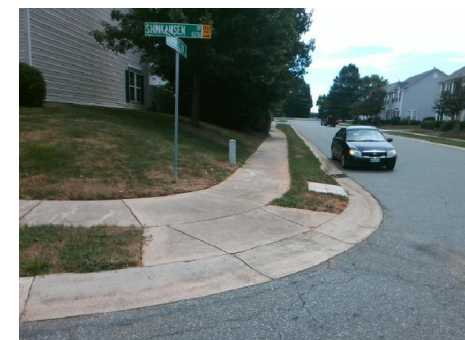
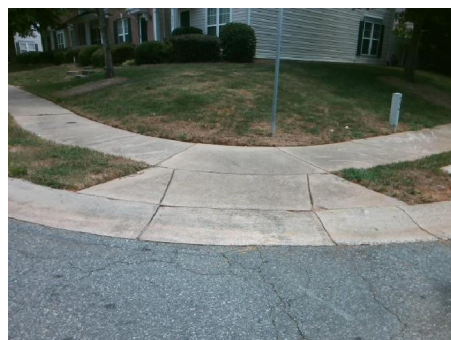
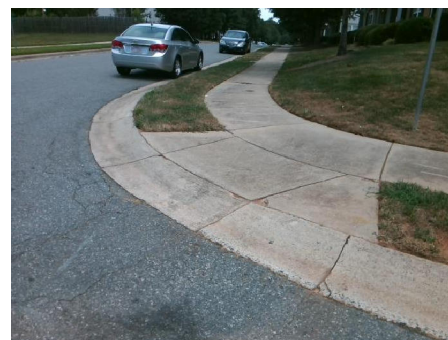
Street 1 Name SHINKANSEN DR  
 Stop Condition-Street 1 StopSign  
 Street 2 Name STOURBRIDGE LION DR  
 Stop Condition-Street 2 None
