Access Compliance Report Public Rights-of-Way (Curb Ramps)

Intersection ID: 13793 Main Street: CLEMENT_AV Cross Street: E_8TH_ST Location: S

ADA ID: CF6D0AE4CE81 Ramp Type: PerpDiag Initial Pass/Fail: Fail Overall Compliance: No Severity Score: 22.5

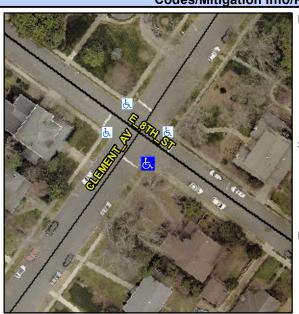
Not Found, R304.5.1, R304.2.2, R304.5.3

r iola indadar ementer compenent compilarios							
	Compliance Description		Data	Compliance		Description	Data
	N/A	Ramp Length (in)	42.0	No	Ramp	Slope (%)	10.3
	No	Ramp Width (in)	45.5	No	Ramp	XSlope (%)	2.6
	N/A	Flare Type LT	N/A	N/A	Flare	Type RT	N/A
	N/A	Flare Slope LT (%)	N/A	N/A	Flare	Slope RT (%)	N/A
	N/A	Flare Traversable LT?	N/A	N/A	Flare	Traversable RT?	N/A
	N/A	Landing Length (in)	N/A	N/A	DWS	Provided?	N/A
	N/A	Landing Width (in)	N/A	N/A	DWS	Contrast?	N/A
	N/A	Landing Slope (%)	N/A	N/A	DWS	Length (in)	N/A
	N/A	Landing X Slope (%)	N/A	N/A	DWS	Full Width?	N/A
	N/A	Landing Curb? (Y/N)	N/A	N/A	DWS	Offset (in)	N/A
	N/A	Shared Landing?	N/A				
	N/A	Gutter Ponding?	Yes	N/A	Gutte	r Slope (%)	N/A
	N/A	Gutter Lip Ht (in)	N/A	N/A	Gutte	r X Slope (%)	N/A
	N/A	Painted X Walk1?	No	N/A	Painte	ed X Walk2?	No
		X Walk 1 Direction	To NE		X Wal	lk 2 Direction	To NW
	N/A	X Walk 1 Width (in)	N/A	N/A	X Wal	lk 2 Width (in)	N/A

X Walk 1 Slope (%)	4.1		X Wal	lk 2 Slope (%)	3.0
		X Walk 1 X Slope (%)	1.7		X Wal	lk 2 X Slope (%)	3.3
	N/A	Ramp inside XWalk1?	N/A	N/A	Ramp	inside XWalk2?	N/A
		Road Slope (%)	3.0	N/A	Clear	Space?	N/A
		Road X Slope (%)	3.4	N/A	Clear	Space to XWalk (in)	N/A

Remove & Replace Curb Ramp With Two New Directional Ramps or Equivalent.
