Access Compliance Report Public Rights-of-Way (Curb Ramps)

Intersection ID: 18980	Main Street: LONDONDERRY_RD	Cross Street: TYVOLA_RD	Location: SE
ADA ID: CF7336BAC080	Ramp Type: PerpDiag	Initial Pass/Fail: Fail	Overall Compliance: No Severity Score: 48.75

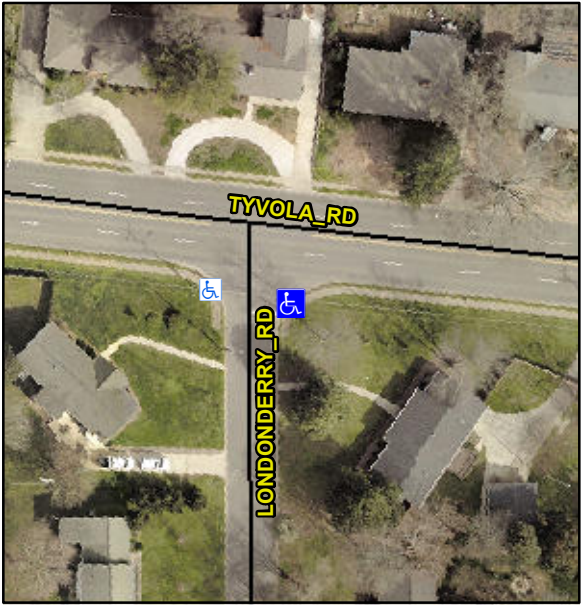
PROW/ADA:
R304.5.1, R304.2.2, R304.5.3

Compliance	Description	Data	Compliance	Description	Data
N/A	Ramp Length (in)	66.0	No	Ramp Slope (%)	9.8
No	Ramp Width (in)	30.0	No	Ramp XSlope (%)	3.0
N/A	Flare Type LT	N/A	N/A	Flare Type RT	N/A
N/A	Flare Slope LT (%)	N/A	N/A	Flare Slope RT (%)	N/A
N/A	Flare Traversable LT?	N/A	N/A	Flare Traversable RT?	N/A
N/A	Landing Length (in)	N/A	N/A	DWS Provided?	N/A
N/A	Landing Width (in)	N/A	N/A	DWS Contrast?	N/A
N/A	Landing Slope (%)	N/A	N/A	DWS Length (in)	N/A
N/A	Landing X Slope (%)	N/A	N/A	DWS Full Width?	N/A
N/A	Landing Curb? (Y/N)	N/A	N/A	DWS Offset (in)	N/A
N/A	Shared Landing?	N/A			
N/A	Gutter Ponding?	N/A	N/A	Gutter Slope (%)	N/A
N/A	Gutter Lip Ht (in)	N/A	N/A	Gutter X Slope (%)	N/A
N/A	Painted X Walk1?	No	N/A	Painted X Walk2?	No
	X Walk 1 Direction	To N		X Walk 2 Direction	To NW
N/A	X Walk 1 Width (in)	N/A	N/A	X Walk 2 Width (in)	N/A
	X Walk 1 Slope (%)	6.2		X Walk 2 Slope (%)	4.2
	X Walk 1 X Slope (%)	1.5		X Walk 2 X Slope (%)	4.4

N/A	Ramp inside XWalk1?	N/A	N/A	Ramp inside XWalk2?	N/A
	Road Slope (%)	1.4	N/A	Clear Space?	N/A
	Road X Slope (%)	6.8	N/A	Clear Space to XWalk (in)	N/A
N/A	Any Obstructions?	N/A	N/A	Storm Grate/Utility Hazard?	N/A
	Obstruction Type			Storm Grate/Utility Type	
		N/A			N/A
			Yes	Surface Condition? (G/P)	Good

Possible Solutions:
Remove & Replace Curb Ramp With Two New Directional Ramps or Equivalent.
