Access Compliance Report Public Rights-of-Way (Curb Ramps)

Intersection ID: 52550 Main Street: MEADOW_BOTTOM_RD Cross Street: KRISTENS_MARE_DR Location: E

ADA ID: CF79997F46EB Ramp Type: PerpDiag Initial Pass/Fail: Fail Overall Compliance: No Severity Score: 1.25

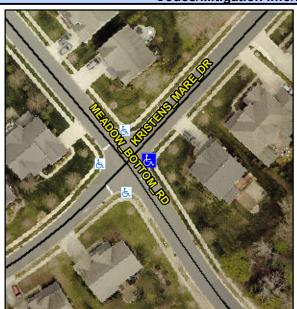
Not Found, R304.5.3

N/A N/A Flare Type LT N/A Flare Type RT N/A N/A N/A N/A Flare Slope RT (%) N/A Flare Slope LT (%) N/A Flare Traversable LT? N/A N/A Flare Traversable RT? N/A N/A N/A N/A **DWS Provided?** N/A Landing Length (in) N/A Landing Width (in) N/A N/A **DWS Contrast?** N/A N/A N/A N/A Landing Slope (%) DWS Length (in) N/A N/A Landing X Slope (%) N/A N/A DWS Full Width? N/A N/A Landing Curb? (Y/N) N/A N/A DWS Offset (in) N/A N/A N/A Shared Landing? N/A Gutter Ponding? N/A N/A Gutter Slope (%) N/A N/A Gutter Lip Ht (in) N/A N/A Gutter X Slope (%) N/A N/A Painted X Walk1? No N/A Painted X Walk2? No X Walk 1 Direction To NW X Walk 2 Direction To SW N/A N/A X Walk 1 Width (in) X Walk 2 Width (in) N/A X Walk 1 Slope (%) X Walk 2 Slope (%) 1.4 1.9 X Walk 1 X Slope (%) 0.2 X Walk 2 X Slope (%) 4.4 N/A N/A N/A Ramp inside XWalk2? Ramp inside XWalk1? N/A Road Slope (%) 3.0 N/A Clear Space? N/A N/A Road X Slope (%) 2.6 Clear Space to XWalk (in) N/A N/A N/A N/A Any Obstructions? Storm Grate/Utility Hazard? N/A **Obstruction Type** Storm Grate/Utility Type N/A N/A

Remove & Replace Curb Ramp With Two New Directional Ramps or Equivalent.
