Access Compliance Report Public Rights-of-Way (Curb Ramps)

Intersection ID: 13639 Main Street: BRIAR_CREEK_RD Cross Street: CENTRAL_AV Location: SW

ADA ID: CF846A4F985D Ramp Type: PerpDiag Initial Pass/Fail: Fail Overall Compliance: No Severity Score: 22.5

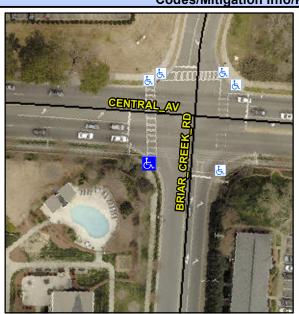
Not Found, R304.5.1, R304.2.2

Field Measurements/Component Compnance						
	Compliance Description		Data	Compliance Description		Data
	N/A	Ramp Length (in)	60.0	No	Ramp Slope (%)	9.5
	No	Ramp Width (in)	46.0	Yes	Ramp XSlope (%)	3.8
	N/A	Flare Type LT	N/A	N/A	Flare Type RT	N/A
	N/A	Flare Slope LT (%)	N/A	N/A	Flare Slope RT (%)	N/A
	N/A	Flare Traversable LT?	N/A	N/A	Flare Traversable RT?	N/A
	N/A	Landing Length (in)	N/A	N/A	DWS Provided?	N/A
	N/A	Landing Width (in)	N/A	N/A	DWS Contrast?	N/A
	N/A	Landing Slope (%)	N/A	N/A	DWS Length (in)	N/A
	N/A	Landing X Slope (%)	N/A	N/A	DWS Full Width?	N/A
	N/A	Landing Curb? (Y/N)	N/A	N/A	DWS Offset (in)	N/A
	N/A	Shared Landing?	N/A			
	N/A	Gutter Ponding?	N/A	N/A	Gutter Slope (%)	N/A
	N/A	Gutter Lip Ht (in)	N/A	N/A	Gutter X Slope (%)	N/A
	N/A	Painted X Walk1?	Yes	N/A	Painted X Walk2?	Yes
		X Walk 1 Direction	To SE		X Walk 2 Direction	To N
	N/A	X Walk 1 Width (in)	119.0	N/A	X Walk 2 Width (in)	100.0
		X Walk 1 Slope (%)	1.3		X Walk 2 Slope (%)	4.7

X Walk 1 X Slope (%)	3.4		X Walk 2 X Slope (%)	3.2
	N/A	Ramp inside XWalk1?	Yes	N/A	Ramp inside XWalk2?	Yes
		Road Slope (%)	4.2	N/A	Clear Space?	N/A
		Road X Slope (%)	0.6	N/A	Clear Space to XWalk (in)	N/A
	N/A	Any Obstructions?	N/A	N/A	Storm Grate/Utility Hazard?	N/A
		Obstruction Type			Storm Grate/Utility Type	
			N/A			N/A
				Yes	Surface Condition? (G/P)	Good
		ADDRESS INTERIOR AND A DESCRIPTION

Remove & Replace Curb Ramp With Two New Directional Ramps or Equivalent.
