Access Compliance Report

Public Rights-of-Way

(Curb Ramps)

Intersection ID: 48450	Main Street: DUSTY_SADDLE_RD	Cross Street: RED_RUST_LN	Location: NW
ADA ID: CF97D507EDC1	Ramp Type: Perp	Initial Pass/Fail: Fail	Overall Compliance: No
Codes/Mitigation Info/Possible Solution		Field Measurements/Component Compliance

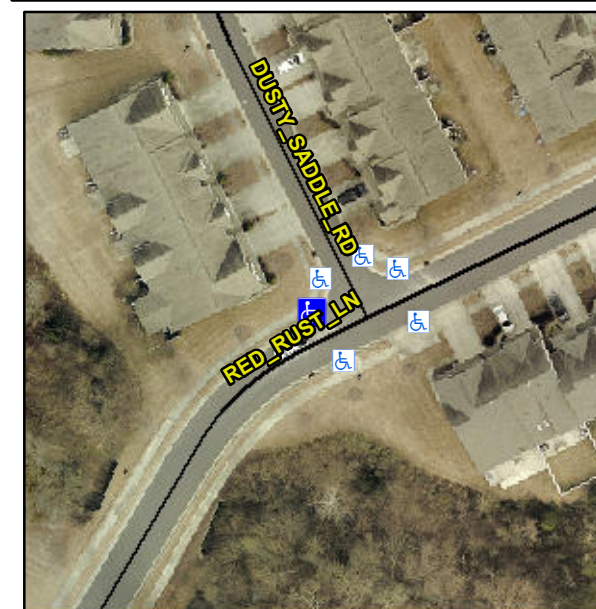
Not Found, R304.5.1, R304.2.2, R304.5.3

Compliance	Description	Data	Compliance	Description	Data
N/A	Ramp Length (in)	37.0	No	Ramp Slope (%)	9.1
No	Ramp Width (in)	35.0	No	Ramp XSlope (%)	2.1
N/A	Flare Type LT	N/A	N/A	Flare Type RT	N/A
N/A	Flare Slope LT (%)	N/A	N/A	Flare Slope RT (%)	N/A
N/A	Flare Traversable LT?	N/A	N/A	Flare Traversable RT?	N/A
N/A	Landing Length (in)	N/A	N/A	DWS Provided?	N/A
N/A	Landing Width (in)	N/A	N/A	DWS Contrast?	N/A
N/A	Landing Slope (%)	N/A	N/A	DWS Length (in)	N/A
N/A	Landing X Slope (%)	N/A	N/A	DWS Full Width?	N/A
N/A	Landing Curb? (Y/N)	N/A	N/A	DWS Offset (in)	N/A
N/A	Shared Landing?	N/A			
N/A	Gutter Ponding?	N/A	N/A	Gutter Slope (%)	N/A
N/A	Gutter Lip Ht (in)	N/A	N/A	Gutter X Slope (%)	N/A
N/A	Painted X Walk1?	No	N/A	Painted X Walk2?	N/A
	X Walk 1 Direction	To SE		X Walk 2 Direction	N/A
N/A	X Walk 1 Width (in)	N/A	N/A	X Walk 2 Width (in)	N/A
	X Walk 1 Slope (%)	1.5		X Walk 2 Slope (%)	N/A
	X Walk 1 X Slope (%)	0.9		X Walk 2 X Slope (%)	N/A

Remove & Replace Entire Ramp.
