# Access Compliance Report

## Public Rights-of-Way

### (Curb Ramps)

Intersection ID: 10038957	Main Street: STONEMEDE_LN	Cross Street: N/A	Location: W
ADA ID: CF9F787C5A2B	Ramp Type: Perp	Initial Pass/Fail: Fail	Overall Compliance: No
Severity Score: 13.75			
Codes/Mitigation Info/Possible Solution		Field Measurements/Component Compliance

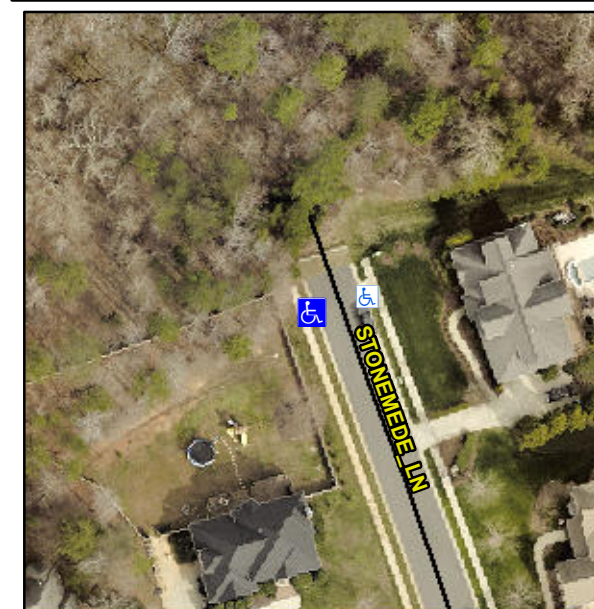
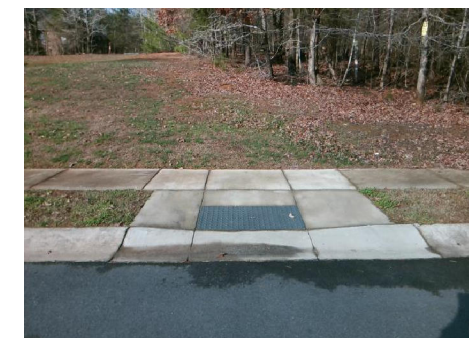
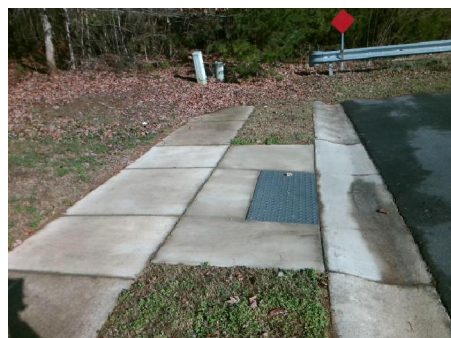
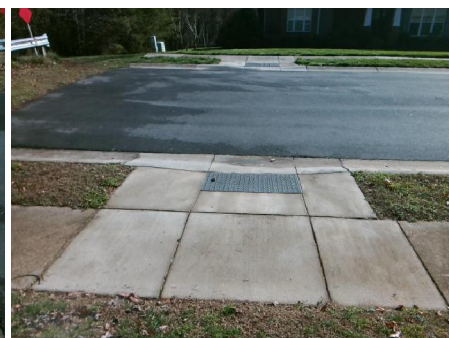
**Not Found, R304.2.2**

Compliance	Description	Data	Compliance	Description	Data
N/A	Ramp Length (in)	46.5	No	Ramp Slope (%)	9.2
Yes	Ramp Width (in)	48.0	Yes	Ramp XSlope (%)	2.2
N/A	Flare Type LT	N/A	N/A	Flare Type RT	N/A
N/A	Flare Slope LT (%)	N/A	N/A	Flare Slope RT (%)	N/A
N/A	Flare Traversable LT?	N/A	N/A	Flare Traversable RT?	N/A
N/A	Landing Length (in)	N/A	N/A	DWS Provided?	N/A
N/A	Landing Width (in)	N/A	N/A	DWS Contrast?	N/A
N/A	Landing Slope (%)	N/A	N/A	DWS Length (in)	N/A
N/A	Landing X Slope (%)	N/A	N/A	DWS Full Width?	N/A
N/A	Landing Curb? (Y/N)	N/A	N/A	DWS Offset (in)	N/A
N/A	Shared Landing?	N/A			
N/A	Gutter Ponding?	N/A	N/A	Gutter Slope (%)	N/A
N/A	Gutter Lip Ht (in)	N/A	N/A	Gutter X Slope (%)	N/A
N/A	Painted X Walk1?	No	N/A	Painted X Walk2?	N/A
	X Walk 1 Direction	To E		X Walk 2 Direction	N/A
N/A	X Walk 1 Width (in)	N/A	N/A	X Walk 2 Width (in)	N/A
	X Walk 1 Slope (%)	1.1		X Walk 2 Slope (%)	N/A
	X Walk 1 X Slope (%)	3.0		X Walk 2 X Slope (%)	N/A

N/A	Ramp inside XWalk1?	N/A	N/A	Ramp inside XWalk2?	N/A
	Road Slope (%)	N/A	N/A	Clear Space?	N/A
	Road X Slope (%)	N/A	N/A	Clear Space to XWalk (in)	N/A
N/A	Any Obstructions?	N/A	N/A	Storm Grate/Utility Hazard?	N/A
	Obstruction Type			Storm Grate/Utility Type	
		N/A			N/A
			Yes	Surface Condition? (G/P)	Good

**Remove & Replace Entire Ramp.**
