Access Compliance Report

Public Rights-of-Way

(Curb Ramps)

Intersection ID: 52611	Main Street: SENATOR_ROYALL_DR	Cross Street: HERITAGE_POND_DR	Location:	N
ADA ID: CFA22E836A83	Ramp Type: Perp	Initial Pass/Fail: Fail	Overall Compliance: No	Severity Score: 25
Codes/Mitigation Info/Possible Solution		Field Measurements/Component Compliance

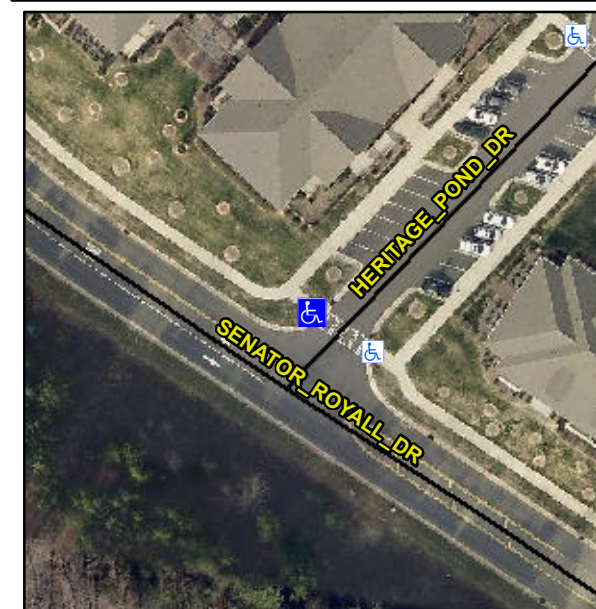
Compliance	Description	Data	Compliance	Description	Data
N/A	Ramp Length (in)	88.0	No	Ramp Slope (%)	14.7
Yes	Ramp Width (in)	85.0	Yes	Ramp XSlope (%)	0.6
N/A	Flare Type LT	N/A	N/A	Flare Type RT	N/A
N/A	Flare Slope LT (%)	N/A	N/A	Flare Slope RT (%)	N/A
N/A	Flare Traversable LT?	N/A	N/A	Flare Traversable RT?	N/A
N/A	Landing Length (in)	N/A	N/A	DWS Provided?	N/A
N/A	Landing Width (in)	N/A	N/A	DWS Contrast?	N/A
N/A	Landing Slope (%)	N/A	N/A	DWS Length (in)	N/A
N/A	Landing X Slope (%)	N/A	N/A	DWS Full Width?	N/A
N/A	Landing Curb? (Y/N)	N/A	N/A	DWS Offset (in)	N/A
N/A	Shared Landing?	N/A			
N/A	Gutter Ponding?	N/A	N/A	Gutter Slope (%)	N/A
N/A	Gutter Lip Ht (in)	N/A	N/A	Gutter X Slope (%)	N/A
N/A	Painted X Walk1?	Yes	N/A	Painted X Walk2?	N/A
	X Walk 1 Direction	To SE		X Walk 2 Direction	N/A
N/A	X Walk 1 Width (in)	104.0	N/A	X Walk 2 Width (in)	N/A
	X Walk 1 Slope (%)	1.4		X Walk 2 Slope (%)	N/A
	X Walk 1 X Slope (%)	0.7		X Walk 2 X Slope (%)	N/A

N/A	Ramp inside XWalk1?	Yes	N/A	Ramp inside XWalk2?	N/A
	Road Slope (%)	N/A	N/A	Clear Space?	N/A
	Road X Slope (%)	N/A	N/A	Clear Space to XWalk (in)	N/A
N/A	Any Obstructions?	N/A	N/A	Storm Grate/Utility Hazard?	N/A
	Obstruction Type			Storm Grate/Utility Type	
		N/A			N/A
			Yes	Surface Condition? (G/P)	Good

Possible Solutions:

Remove & Replace Entire Ramp.

R304.2.2

Total Cost: \$ 1850.00
