Access Compliance Report

Public Rights-of-Way

(Curb Ramps)

Intersection ID: 48454	Main Street: RED_RUST_LN	Cross Street: GOLF_LINKS_DR	Location: SW
ADA ID: CFA3A9CC3934	Ramp Type: Perp	Initial Pass/Fail: Pass	Overall Compliance: Yes
		Severity Score: 0

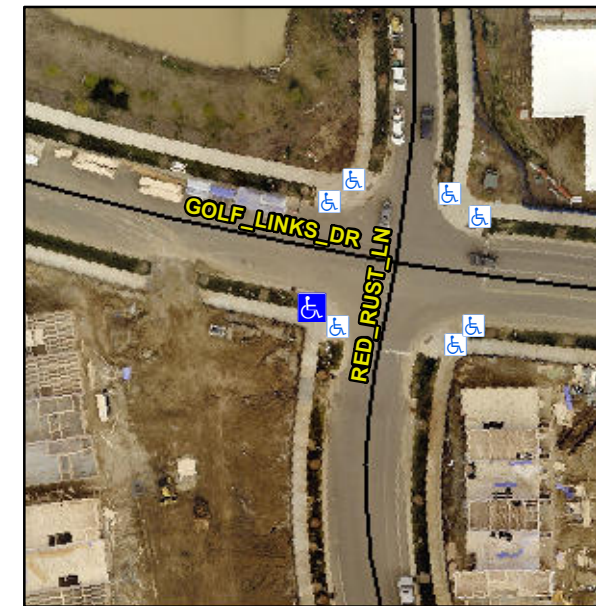
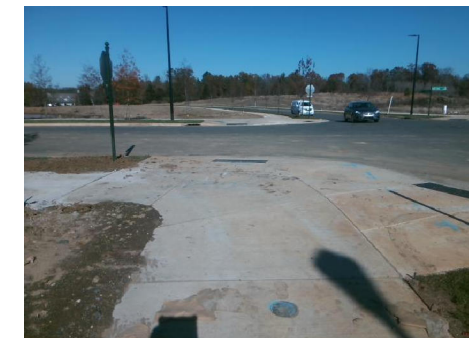
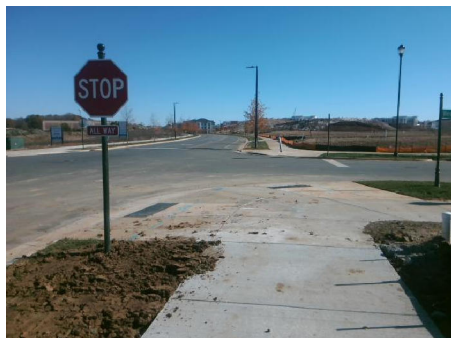
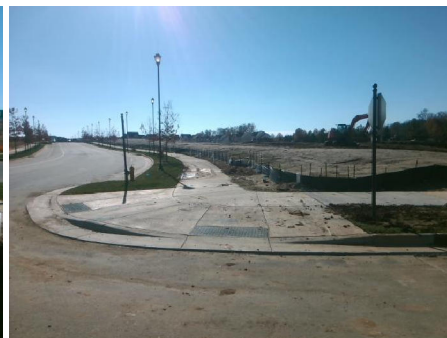
Compliance	Description	Data	Compliance	Description	Data
N/A	Ramp Length (in)	93.0	Yes	Ramp Slope (%)	6.3
Yes	Ramp Width (in)	50.0	Yes	Ramp XSlope (%)	2.0
N/A	Flare Type LT	Sloped	N/A	Flare Type RT	N/A
N/A	Flare Slope LT (%)	3.9	Yes	Flare Slope RT (%)	1.9
N/A	Flare Traversable LT?	Yes	N/A	Flare Traversable RT?	Yes
Yes	Landing Length (in)	100.0	Yes	DWS Provided?	Yes
Yes	Landing Width (in)	50.0	Yes	DWS Contrast?	Yes
Yes	Landing Slope (%)	0.9	Yes	DWS Length (in)	24.0
Yes	Landing X Slope (%)	0.3	Yes	DWS Full Width?	Yes
N/A	Landing Curb? (Y/N)	No	Yes	DWS Offset (in)	1.5
N/A	Shared Landing?	No			
Yes	Gutter Ponding?	No	Yes	Gutter Slope (%)	2.8
Yes	Gutter Lip Ht (in)	0.0	Yes	Gutter X Slope (%)	1.4
N/A	Painted X Walk1?	No	N/A	Painted X Walk2?	N/A
	X Walk 1 Direction	To N		X Walk 2 Direction	N/A
N/A	X Walk 1 Width (in)	N/A	N/A	X Walk 2 Width (in)	N/A
	X Walk 1 Slope (%)	2.3		X Walk 2 Slope (%)	N/A
	X Walk 1 X Slope (%)	1.0		X Walk 2 X Slope (%)	N/A

N/A	Ramp inside XWalk1?	N/A	N/A	Ramp inside XWalk2?	N/A
	Road Slope (%)	N/A	N/A	Clear Space?	Yes
	Road X Slope (%)	N/A	N/A	Clear Space to XWalk (in)	N/A
Yes	Any Obstructions?	No	Yes	Storm Grate/Utility Hazard?	No
	Obstruction Type			Storm Grate/Utility Type	
			N/A		N/A
			Yes	Surface Condition? (G/P)	Good
