Access Compliance Report

Public Rights-of-Way

(Curb Ramps)

Intersection ID: 18756	Main Street: RIGSBY_RD	Cross Street: STEELE_CREEK_RD	Location: NW
ADA ID: CFAA098E9517	Ramp Type: PerpDiag	Initial Pass/Fail: Fail	Overall Compliance: No
			Severity Score: 21.25

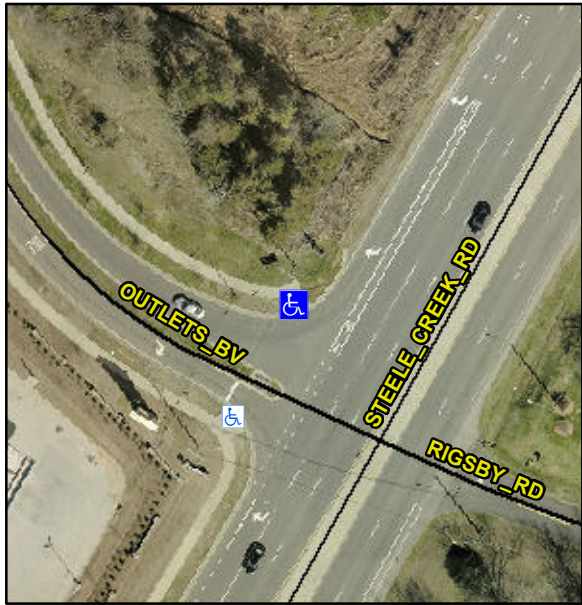
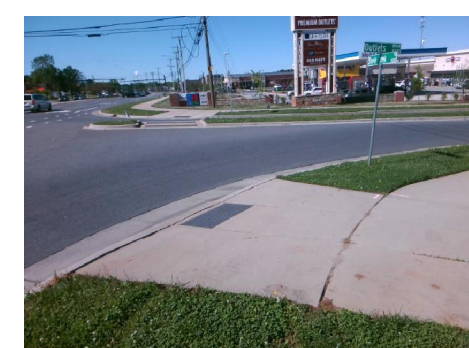
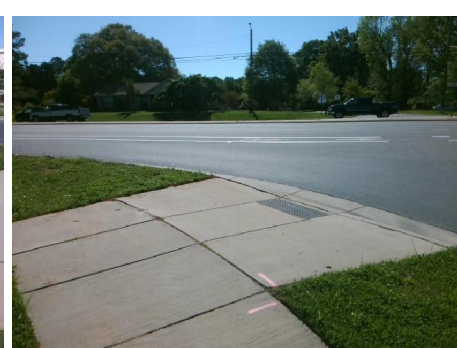
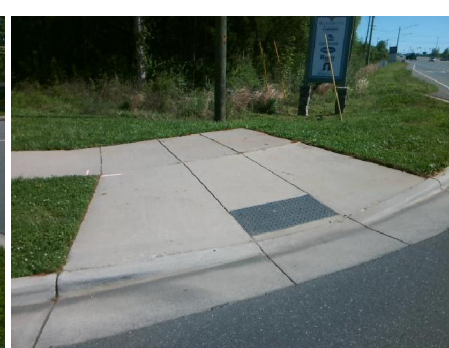
Possible Solutions:		Compliance	Description	Data	Compliance	Description	Data
	Remove & Replace Curb Ramp With Two New Directional Ramps or Equivalent.		N/A	Ramp Length (in)	102.0	Yes	Ramp Slope (%)	6.7
			No	Ramp Width (in)	42.5	No	Ramp XSlope (%)	6.9
			N/A	Flare Type LT	N/A	N/A	Flare Type RT	N/A
			N/A	Flare Slope LT (%)	N/A	N/A	Flare Slope RT (%)	N/A
			N/A	Flare Traversable LT?	N/A	N/A	Flare Traversable RT?	N/A
			N/A	Landing Length (in)	N/A	N/A	DWS Provided?	N/A
			N/A	Landing Width (in)	N/A	N/A	DWS Contrast?	N/A
			N/A	Landing Slope (%)	N/A	N/A	DWS Length (in)	N/A
			N/A	Landing X Slope (%)	N/A	N/A	DWS Full Width?	N/A
<p>Surveyor Notes:</p> <p>N/A</p>			N/A	Landing Curb? (Y/N)	N/A	N/A	DWS Offset (in)	N/A
			N/A	Shared Landing?	N/A			
			N/A	Gutter Ponding?	N/A	N/A	Gutter Slope (%)	N/A
			N/A	Gutter Lip Ht (in)	N/A	N/A	Gutter X Slope (%)	N/A

N/A	Painted X Walk1?	No	N/A	Painted X Walk2?	No
				X Walk 1 Direction	To SW		X Walk 2 Direction	To SE
			N/A	X Walk 1 Width (in)	N/A	N/A	X Walk 2 Width (in)	N/A
				X Walk 1 Slope (%)	0.4		X Walk 2 Slope (%)	5.9
				X Walk 1 X Slope (%)	7.8		X Walk 2 X Slope (%)	0.8
			N/A	Ramp inside XWalk1?	N/A	N/A	Ramp inside XWalk2?	N/A
<p>PROW/ADA:</p> <p>Not Found, R304.5.1, R304.5.3</p>				Road Slope (%)	5.0	N/A	Clear Space?	N/A
				Road X Slope (%)	4.4	N/A	Clear Space to XWalk (in)	N/A
			N/A	Any Obstructions?	N/A	N/A	Storm Grate/Utility Hazard?	N/A
				Obstruction Type			Storm Grate/Utility Type	
						N/A		N/A
						Yes	Surface Condition? (G/P)	Good
Total Cost:		\$ 3200.00
