Access Compliance Report

Public Rights-of-Way

(Curb Ramps)

Intersection ID: 14071	Main Street: CLEVELAND_AV	Cross Street: E_KINGSTON_AV	Location: S
ADA ID: CFACD98E098C	Ramp Type: Directional1	Initial Pass/Fail: Fail	Overall Compliance: No
Codes/Mitigation Info/Possible Solution		Field Measurements/Component Compliance	
Severity Score: 13.75

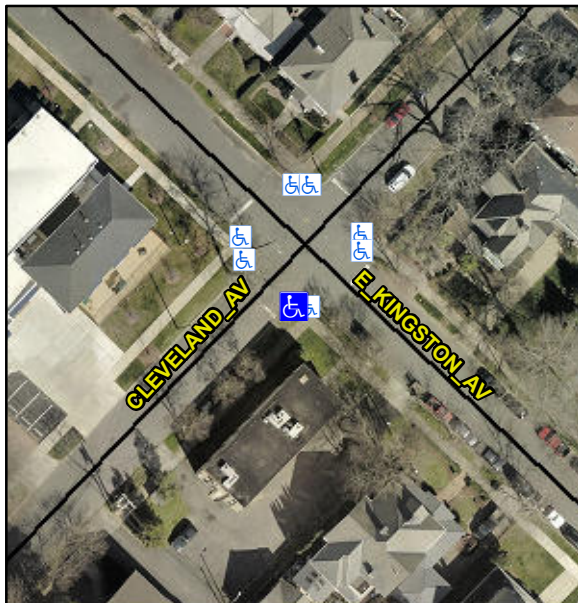
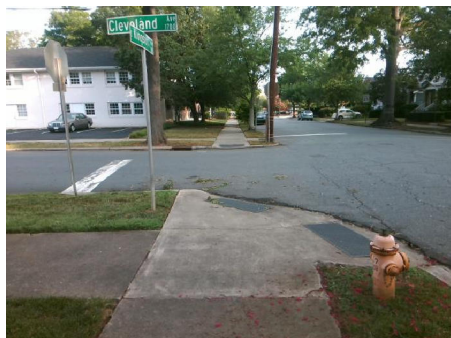
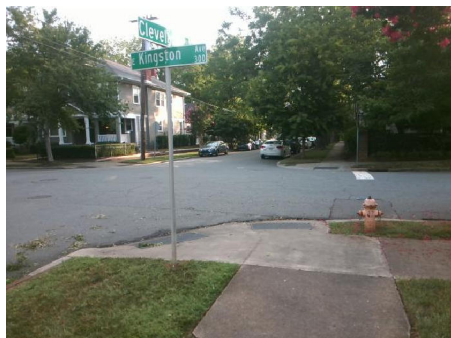
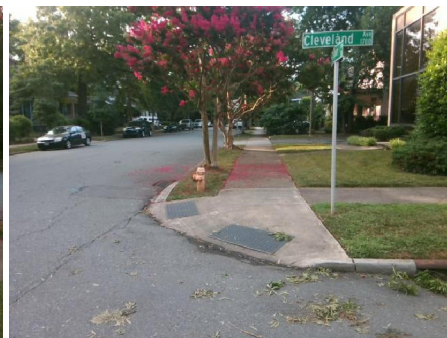
NO CURB LINE

R304.2.2, R304.5.3

Compliance	Description	Data	Compliance	Description	Data
N/A	Ramp Length (in)	48.0	N/A	Grade Break?	N/A
Yes	Ramp Width (in)	60.0	N/A	Grade Break Slope (%)	0.0
No	Ramp Slope (%)	10.5	N/A	Grade Break XSlope (%)	0.0
No	Ramp XSlope (%)	3.0			
N/A	Flare Type LT	N/A	N/A	Flare Type RT	N/A
N/A	Flare Slope LT (%)	N/A	N/A	Flare Slope RT (%)	0.0
N/A	Flare Traversable LT?	N/A	N/A	Flare Traversable RT?	N/A
N/A	Landing Length (in)	0.0	N/A	DWS Provided?	N/A
N/A	Landing Width (in)	0.0	N/A	DWS Contrast?	N/A
N/A	Landing Slope (%)	0.0	N/A	DWS Length (in)	N/A
N/A	Landing X Slope (%)	0.0	N/A	DWS Full Width?	N/A
N/A	Landing Curb? (Y/N)	N/A	N/A	DWS Offset LT (in)	N/A
N/A	Shared Landing?	N/A	N/A	DWS Offset RT (in)	N/A
N/A	Gutter Ponding?	0.0	N/A	Gutter Slope (%)	N/A
N/A	Gutter Lip Ht (in)	0.0	N/A	Gutter X Slope (%)	N/A
N/A	Painted X Walk1?	No		Road Slope (%)	3.9
	X Walk 1 Direction	To NW		Road X Slope (%)	0.4
	X Walk 1 Width (in)	N/A		Clear Space?	N/A

X Walk 1 Slope (%)	3.9	N/A	Clear Space to XWalk (in)	N/A
	X Walk 1 X Slope (%)	0.4	N/A	Storm Grate/Utility Hazard?	N/A
N/A	Ramp inside XWalk1?	N/A		Storm Grate/Utility Type	
N/A	Any Obstructions?	N/A			N/A
	Obstruction Type		Yes	Surface Condition? (G/P)	Good
			N/A	Curb Slope (%)	11.8

Remove & Replace Entire Ramp.
