Access Compliance Report

Public Rights-of-Way

(Curb Ramps)

Intersection ID: 10036062	Main Street: RIVERGATE_PY	Cross Street: N/A	Location: SE
ADA ID: CFAED07A3EB1	Ramp Type: BlendTrans1	Initial Pass/Fail: Fail	Overall Compliance: No
Severity Score: 12.5			
Codes/Mitigation Info/Possible Solution		Field Measurements/Component Compliance

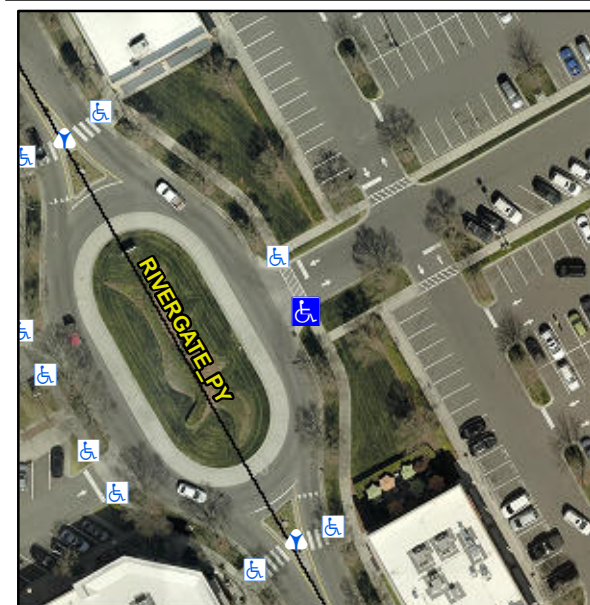
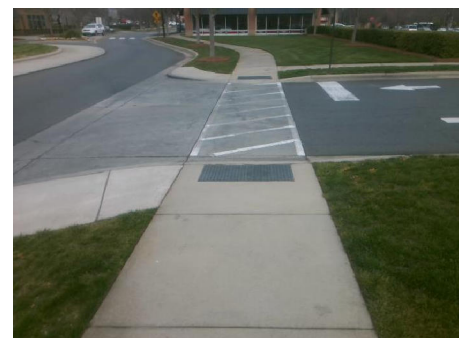
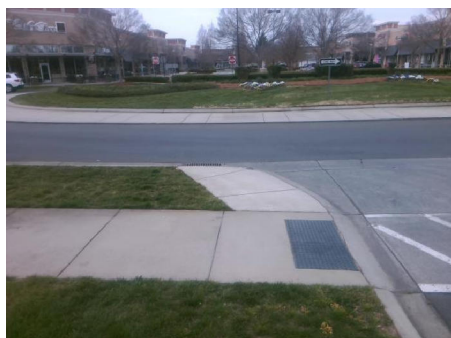
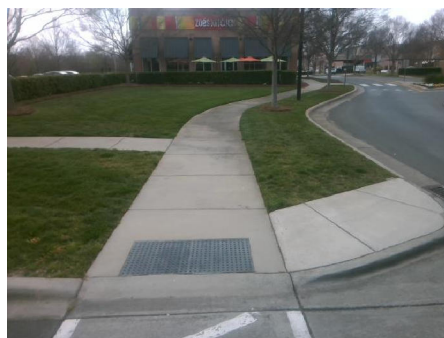
Not Found, R304.5.3

Compliance	Description	Data	Compliance	Description	Data
N/A	Ramp Length (in)	59.0	Yes	BlendTrans Slope (%)	3.0
Yes	Ramp Width (in)	72.0	No	BlendTrans XSlope (%)	5.1
N/A	Flare Type LT	N/A	N/A	Flare Type RT	N/A
N/A	Flare Slope LT (%)	N/A	N/A	Flare Slope RT (%)	N/A
N/A	Flare Traversable LT?	N/A	N/A	Flare Traversable RT?	N/A
N/A	Landing Length (in)	N/A	N/A	DWS Provided?	N/A
N/A	Landing Width (in)	N/A	N/A	DWS Contrast?	N/A
N/A	Landing Slope (%)	N/A	N/A	DWS Length (in)	N/A
N/A	Landing X Slope (%)	N/A	N/A	DWS Full Width?	N/A
N/A	Landing Curb? (Y/N)	N/A	N/A	DWS Offset (in)	N/A
N/A	Shared Landing?	N/A			
N/A	Gutter Ponding?	N/A	N/A	Gutter Slope (%)	N/A
N/A	Gutter Lip Ht (in)	N/A	N/A	Gutter X Slope (%)	N/A
N/A	Painted X Walk1?	Yes	N/A	Painted X Walk2?	N/A
	X Walk 1 Direction	To NW		X Walk 2 Direction	N/A
	X Walk 1 Width (in)	63.0		X Walk 2 Width (in)	N/A
	X Walk 1 Slope (%)	1.9		X Walk 2 Slope (%)	N/A
	X Walk 1 X Slope (%)	0.8		X Walk 2 X Slope (%)	N/A

N/A	Ramp inside XWalk1?	Yes	N/A	Ramp inside XWalk2?	N/A
	Road Slope (%)	0.8		Clear Space?	N/A
	Road X Slope (%)	1.9	N/A	Clear Space to XWalk (in)	N/A
N/A	Any Obstructions?	N/A	N/A	Storm Grate/Utility Hazard?	N/A
	Obstruction Type			Storm Grate/Utility Type	
		N/A			N/A
			Yes	Surface Condition? (G/P)	Good
			No	Curb Slope (%)	21.9

Remove & Replace Curb Ramp With Two New Directional Ramps or Equivalent.

Total Cost: \$ 3200.00
