Access Compliance Report

Public Rights-of-Way

(Curb Ramps)

Intersection ID: 10015096	Main Street: N_SHARON_AMITY_RD	Cross Street: N/A	Location: SE
ADA ID: CFBB6481CFB3	Ramp Type: PerpDiag	Initial Pass/Fail: Fail	Overall Compliance: No
		Severity Score: 12.5

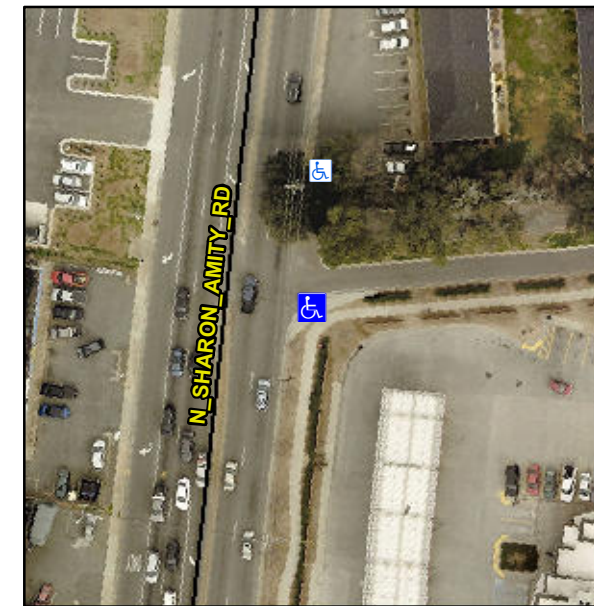
Compliance	Description	Data	Compliance	Description	Data
N/A	Ramp Length (in)	96.0	No	Ramp Slope (%)	8.9
Yes	Ramp Width (in)	89.0	Yes	Ramp XSlope (%)	1.1
N/A	Flare Type LT	N/A	N/A	Flare Type RT	N/A
N/A	Flare Slope LT (%)	N/A	N/A	Flare Slope RT (%)	N/A
N/A	Flare Traversable LT?	N/A	N/A	Flare Traversable RT?	N/A
N/A	Landing Length (in)	N/A	N/A	DWS Provided?	N/A
N/A	Landing Width (in)	N/A	N/A	DWS Contrast?	N/A
N/A	Landing Slope (%)	N/A	N/A	DWS Length (in)	N/A
N/A	Landing X Slope (%)	N/A	N/A	DWS Full Width?	N/A
N/A	Landing Curb? (Y/N)	N/A	N/A	DWS Offset (in)	N/A
N/A	Shared Landing?	N/A			
N/A	Gutter Ponding?	N/A	N/A	Gutter Slope (%)	N/A
N/A	Gutter Lip Ht (in)	N/A	N/A	Gutter X Slope (%)	N/A
N/A	Painted X Walk1?	No	N/A	Painted X Walk2?	No
	X Walk 1 Direction	To N		X Walk 2 Direction	To W
N/A	X Walk 1 Width (in)	N/A	N/A	X Walk 2 Width (in)	N/A
	X Walk 1 Slope (%)	2.3		X Walk 2 Slope (%)	1.3
	X Walk 1 X Slope (%)	3.5		X Walk 2 X Slope (%)	1.9

N/A	Ramp inside XWalk1?	N/A	N/A	Ramp inside XWalk2?	N/A
	Road Slope (%)	2.8	N/A	Clear Space?	N/A
	Road X Slope (%)	4.0	N/A	Clear Space to XWalk (in)	N/A
N/A	Any Obstructions?	N/A	N/A	Storm Grate/Utility Hazard?	N/A
	Obstruction Type			Storm Grate/Utility Type	
		N/A			N/A
			Yes	Surface Condition? (G/P)	Good

Possible Solutions:

Remove & Replace Curb Ramp With Two New Directional Ramps or Equivalent.

R304.2.2
