# Access Compliance Report

## Public Rights-of-Way

### (Curb Ramps)

Intersection ID: 13679	Main Street: EUCLID_AV	Cross Street: LEXINGTON_AV	Location: S
ADA ID: CFBF115477A6	Ramp Type: Directional1	Initial Pass/Fail: Fail	Overall Compliance: No
			Severity Score: 13.75

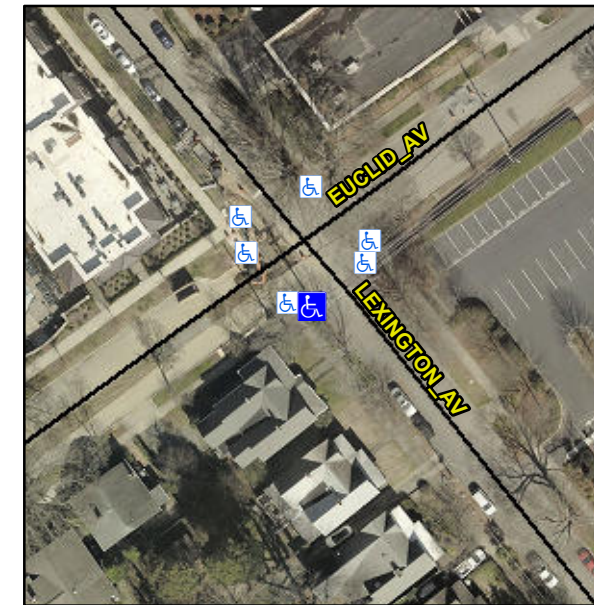
Compliance	Description	Data	Compliance	Description	Data
N/A	Ramp Length (in)	70.0	N/A	Grade Break?	N/A
Yes	Ramp Width (in)	58.0	N/A	Grade Break Slope (%)	0.0
No	Ramp Slope (%)	8.9	N/A	Grade Break XSlope (%)	0.0
No	Ramp XSlope (%)	4.1			
N/A	Flare Type LT	N/A	N/A	Flare Type RT	N/A
N/A	Flare Slope LT (%)	N/A	N/A	Flare Slope RT (%)	0.0
N/A	Flare Traversable LT?	N/A	N/A	Flare Traversable RT?	N/A
N/A	Landing Length (in)	0.0	N/A	DWS Provided?	N/A
N/A	Landing Width (in)	0.0	N/A	DWS Contrast?	N/A
N/A	Landing Slope (%)	0.0	N/A	DWS Length (in)	N/A
N/A	Landing X Slope (%)	0.0	N/A	DWS Full Width?	N/A
N/A	Landing Curb? (Y/N)	N/A	N/A	DWS Offset LT (in)	N/A
N/A	Shared Landing?	N/A	N/A	DWS Offset RT (in)	N/A
N/A	Gutter Ponding?	0.0	N/A	Gutter Slope (%)	N/A
N/A	Gutter Lip Ht (in)	0.0	N/A	Gutter X Slope (%)	N/A
N/A	Painted X Walk1?	No		Road Slope (%)	3.0
	X Walk 1 Direction	To NE		Road X Slope (%)	2.7
	X Walk 1 Width (in)	N/A		Clear Space?	N/A

X Walk 1 Slope (%)	3.0	N/A	Clear Space to XWalk (in)	N/A
	X Walk 1 X Slope (%)	2.7	N/A	Storm Grate/Utility Hazard?	N/A
N/A	Ramp inside XWalk1?	N/A		Storm Grate/Utility Type	
N/A	Any Obstructions?	N/A			N/A
	Obstruction Type		Yes	Surface Condition? (G/P)	Good
			N/A	Curb Slope (%)	15.4

**Remove & Replace Entire Ramp.**

**R304.2.2, R304.5.3**
