Access Compliance Report Public Rights-of-Way (Curb Ramps)

Intersection ID: 29818 Main Street: WEDGEWOOD_COMMONS_DRCross Street: MINA_CT Location: Ε

ADA ID: CFC03904E7D9 Ramp Type: PerpDiag Initial Pass/Fail: Fail **Overall Compliance: No Severity Score:** 25

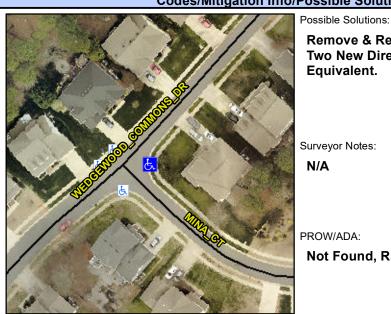
Not Found, R304.5.3

5 (1)	
N/A	Ramp Length (in)	49.0	Yes	Ramp Slope (%)	5.6
Yes	Ramp Width (in)	48.0	No	Ramp XSlope (%)	10.2
N/A	Flare Type LT	N/A	N/A	Flare Type RT	N/A
N/A	Flare Slope LT (%)	N/A	N/A	Flare Slope RT (%)	N/A
N/A	Flare Traversable LT?	N/A	N/A	Flare Traversable RT?	N/A
N/A	Landing Length (in)	N/A	N/A	DWS Provided?	N/A
N/A	Landing Width (in)	N/A	N/A	DWS Contrast?	N/A
N/A	Landing Slope (%)	N/A	N/A	DWS Length (in)	N/A
N/A	Landing X Slope (%)	N/A	N/A	DWS Full Width?	N/A
N/A	Landing Curb? (Y/N)	N/A	N/A	DWS Offset (in)	N/A
N/A	Shared Landing?	N/A			
N/A	Gutter Ponding?	N/A	N/A	Gutter Slope (%)	N/A
N/A	Gutter Lip Ht (in)	N/A	N/A	Gutter X Slope (%)	N/A
N/A	Painted X Walk1?	No	N/A	Painted X Walk2?	No
	X Walk 1 Direction	To NW		X Walk 2 Direction	To SW
N/A	X Walk 1 Width (in)	N/A	N/A	X Walk 2 Width (in)	N/A
	X Walk 1 Slope (%)	4.4		X Walk 2 Slope (%)	6.5
	X Walk 1 X Slope (%)	9.0		X Walk 2 X Slope (%)	2.7
N/A	Ramp inside XWalk1?	N/A	N/A	Ramp inside XWalk2?	N/A

Road Slope (%)	7.5	N/A	Clear Space?	N/A
	Road X Slope (%)	2.7	N/A	Clear Space to XWalk (in)	N/A
N/A	Any Obstructions?	N/A	N/A	Storm Grate/Utility Hazard?	N/A
	Obstruction Type		l	Storm Grate/Utility Type	
		N/A			N/A

WEDGEWOOD COMMO Street 1 Name Stop Condition-Street 2 Street 2 Name MI Stop Condition-Street 1 Sto Remove & Replace Curb Ramp With **Two New Directional Ramps or** Equivalent.
