# Access Compliance Report

## Public Rights-of-Way

| Intersection ID: 14820 | Main Street: BLYTHE_BV | Cross Street: SCOTT_AV | Location: NE |
| ADA ID: CFC9EC06974F | Ramp Type: PerpDiag | Initial Pass/Fail: Fail | Overall Compliance: No |

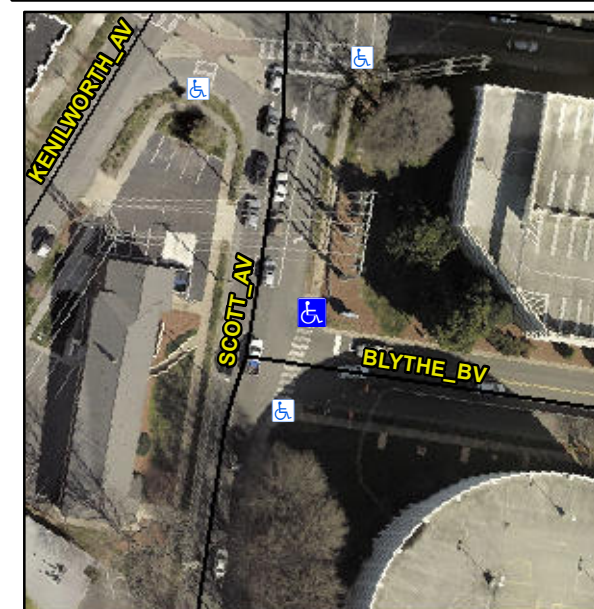
**R304.5.1, R304.2.2, R304.5.3**

| Compliance | Description | Data | Compliance | Description | Data |
|---|---|---|---|---|---|
| N/A | Ramp Length (in) | 73.0 | No | Ramp Slope (%) | 9.3 |
| No | Ramp Width (in) | 34.5 | No | Ramp XSlope (%) | 10.7 |

**Remove & Replace Curb Ramp With Two New Directional Ramps or Equivalent.**
