| Intersection ID: 13288 | Main Street: MAYFAIR_AV | Cross Street: SEYMOUR_DR | Location: | S |
| ADA ID: CFCAB884F484 | Ramp Type: PerpDiag | Initial Pass/Fail: Fail | Overall Compliance: No | Severity Score: 47.5 |

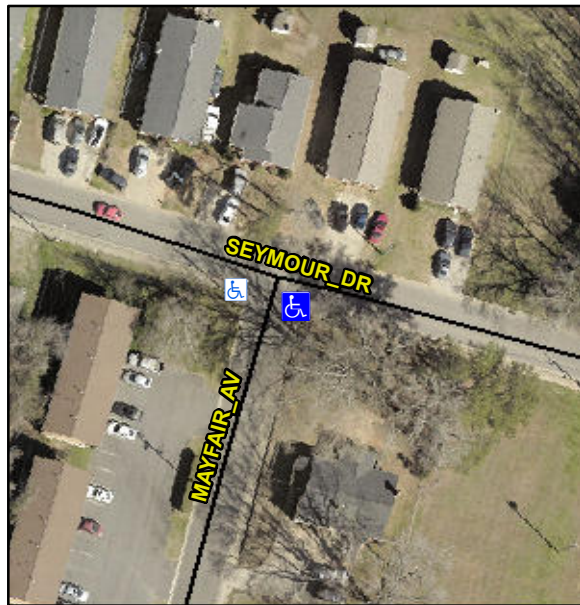
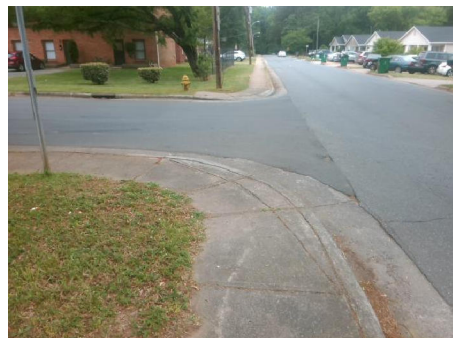
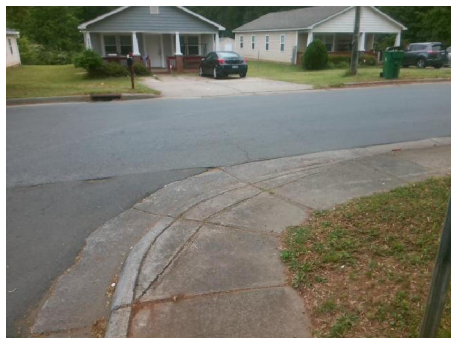
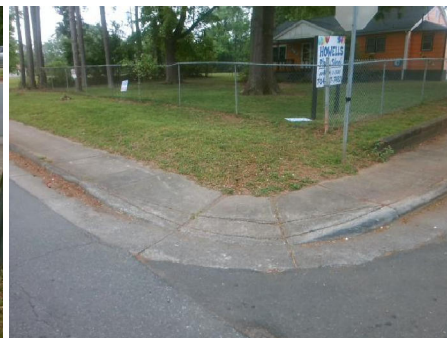
| Compliance | Description | Data | Compliance | Description | Data |
|---|---|---|---|---|---|
| N/A | Ramp Length (in) | 48.0 | No | Ramp Slope (%) | 9.0 |
| No | Ramp Width (in) | 28.0 | Yes | Ramp XSlope (%) | 2.0 |

Remove & Replace Curb Ramp With Two New Directional Ramps or Equivalent.
