# Access Compliance Report

## Public Rights-of-Way

| Intersection ID: 45793 | Main Street: WINDING_RIVER_DR | Cross Street: GRANITE_TRAIL_LN | Location: NW |
| ADA ID: CFDCFA279B99 | Ramp Type: BlendTrans1 | Initial Pass/Fail: Fail | Overall Compliance: No |

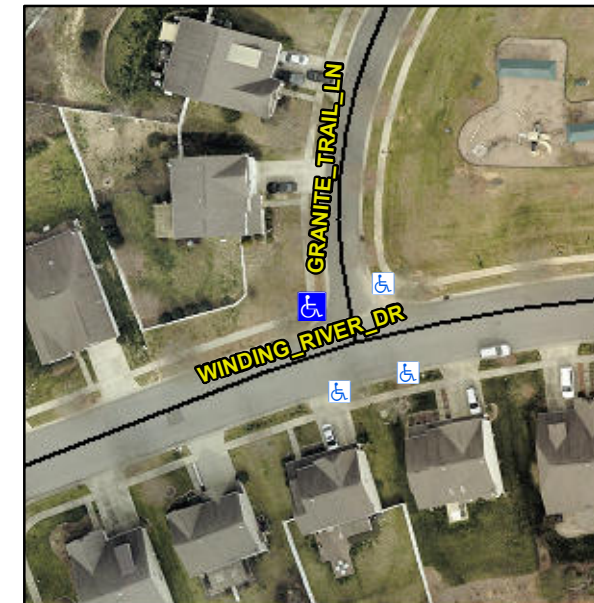
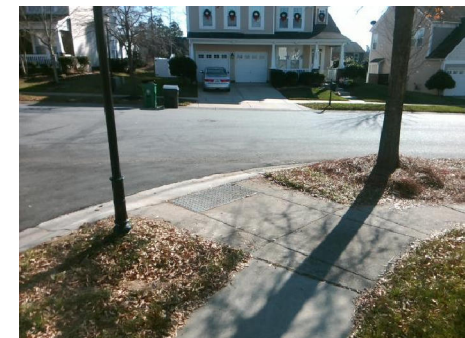
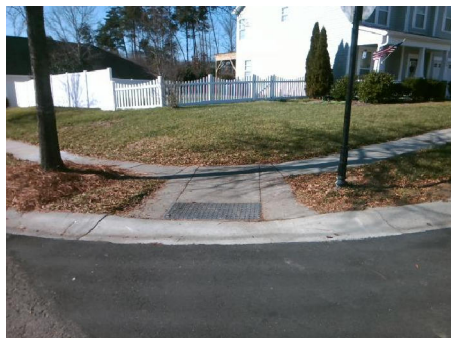
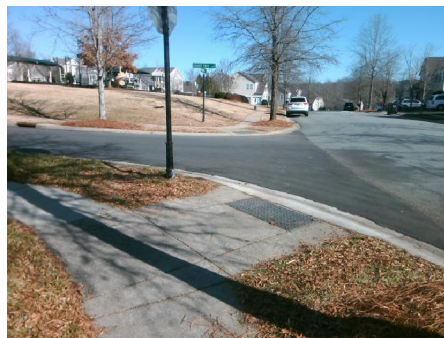
| | | Severity Score: 10 | |

**Not Found, R304.5.1, R304.5.3**

| Compliance | Description | Data | Compliance | Description | Data |
|---|---|---|---|---|---|
| No | Ramp Width (in) | 47.5 | No | BlendTrans XSlope (%) | 3.7 |

**Remove & Replace Curb Ramp With Two New Directional Ramps or Equivalent.**
