# Access Compliance Report

## Public Rights-of-Way

### (Curb Ramps)

| Intersection ID: 48475 | Main Street: SHALLOW_OAK_CT | Cross Street: AUTUMN_OAK_DR | Location: S |

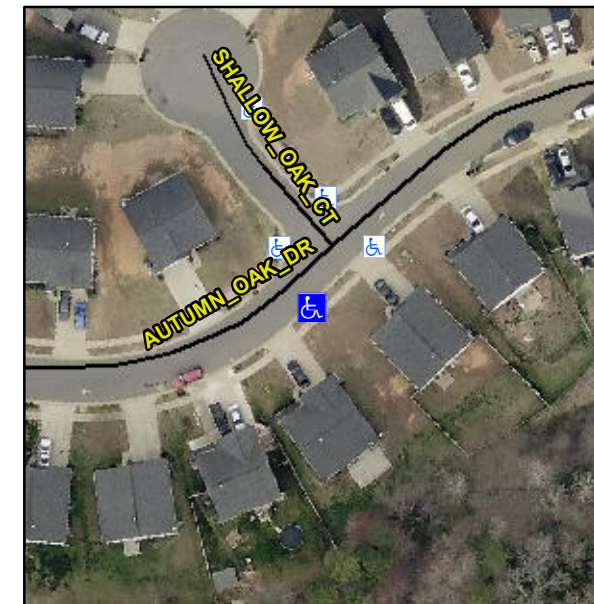
| ADA ID: CFE25CC5CDEE | Ramp Type: Perp | Initial Pass/Fail: Fail | Overall Compliance: No |

| Severity Score: 35 | | | |

**Not Found, R304.5.1, R304.2.2**

| Compliance | Description | Data | Compliance | Description | Data |
|---|---|---|---|---|---|
| N/A | Ramp Length (in) | 46.0 | No | Ramp Slope (%) | 15.6 |
| No | Ramp Width (in) | 47.5 | Yes | Ramp XSlope (%) | 3.5 |

**Remove & Replace Entire Ramp.**
