Access Compliance Report

Public Rights-of-Way (Curb Ramps)

Intersection ID: 12300	Main Street: BELLE_TERRE_AV	Cross Street: NASSAU_BV	Location: SW
ADA ID: CFE45C50CB00	Ramp Type: Directional1	Initial Pass/Fail: Fail	Overall Compliance: No
		Severity Score: 1.25

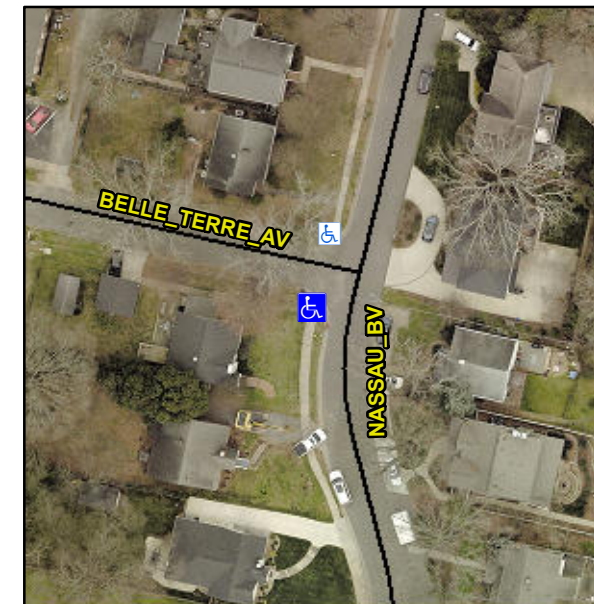
Compliance	Description	Data	Compliance	Description	Data
N/A	Ramp Length (in)	85.0	N/A	Grade Break?	N/A
Yes	Ramp Width (in)	50.0	N/A	Grade Break Slope (%)	0.0
Yes	Ramp Slope (%)	5.2	N/A	Grade Break XSlope (%)	0.0
No	Ramp XSlope (%)	3.3			
N/A	Flare Type LT	N/A	N/A	Flare Type RT	N/A
N/A	Flare Slope LT (%)	N/A	N/A	Flare Slope RT (%)	0.0
N/A	Flare Traversable LT?	N/A	N/A	Flare Traversable RT?	N/A
N/A	Landing Length (in)	0.0	N/A	DWS Provided?	N/A
N/A	Landing Width (in)	0.0	N/A	DWS Contrast?	N/A
N/A	Landing Slope (%)	0.0	N/A	DWS Length (in)	N/A
N/A	Landing X Slope (%)	0.0	N/A	DWS Full Width?	N/A
N/A	Landing Curb? (Y/N)	N/A	N/A	DWS Offset LT (in)	N/A
N/A	Shared Landing?	N/A	N/A	DWS Offset RT (in)	N/A
N/A	Gutter Ponding?	0.0	N/A	Gutter Slope (%)	N/A
N/A	Gutter Lip Ht (in)	0.0	N/A	Gutter X Slope (%)	N/A
N/A	Painted X Walk1?	No		Road Slope (%)	0.8
	X Walk 1 Direction	To N		Road X Slope (%)	1.7
	X Walk 1 Width (in)	N/A		Clear Space?	N/A

X Walk 1 Slope (%)	0.8	N/A	Clear Space to XWalk (in)	N/A
	X Walk 1 X Slope (%)	1.7	N/A	Storm Grate/Utility Hazard?	N/A
N/A	Ramp inside XWalk1?	N/A		Storm Grate/Utility Type	
N/A	Any Obstructions?	N/A			N/A
	Obstruction Type		Yes	Surface Condition? (G/P)	Good
			N/A	Curb Slope (%)	24.5

Remove & Replace Entire Ramp.

R304.5.3

\$ 1600.00
