Access Compliance Report

Public Rights-of-Way

(Curb Ramps)

Intersection ID: 12609	Main Street: KENSINGTON_DR	Cross Street: PECAN_AV	Location: SE
ADA ID: CFEEC80BFCCB	Ramp Type: Perp	Initial Pass/Fail: Fail	Overall Compliance: No
Severity Score: 23.75			
Codes/Mitigation Info/Possible Solution		Field Measurements/Component Compliance

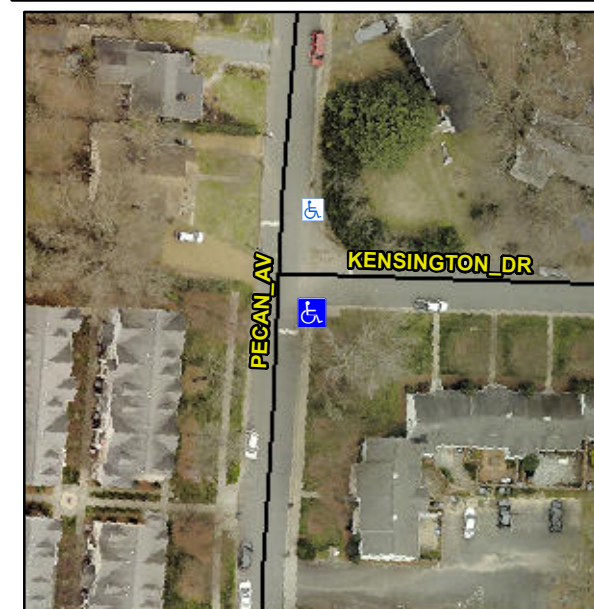
Not Found, R304.5.1, R302.7

Compliance	Description	Data	Compliance	Description	Data
N/A	Ramp Length (in)	48.0	Yes	Ramp Slope (%)	6.3
No	Ramp Width (in)	44.0	Yes	Ramp XSlope (%)	0.1
N/A	Flare Type LT	N/A	N/A	Flare Type RT	N/A
N/A	Flare Slope LT (%)	N/A	N/A	Flare Slope RT (%)	N/A
N/A	Flare Traversable LT?	N/A	N/A	Flare Traversable RT?	N/A
N/A	Landing Length (in)	N/A	N/A	DWS Provided?	N/A
N/A	Landing Width (in)	N/A	N/A	DWS Contrast?	N/A
N/A	Landing Slope (%)	N/A	N/A	DWS Length (in)	N/A
N/A	Landing X Slope (%)	N/A	N/A	DWS Full Width?	N/A
N/A	Landing Curb? (Y/N)	N/A	N/A	DWS Offset (in)	N/A
N/A	Shared Landing?	N/A			
N/A	Gutter Ponding?	N/A	N/A	Gutter Slope (%)	N/A
N/A	Gutter Lip Ht (in)	4.0	N/A	Gutter X Slope (%)	N/A
N/A	Painted X Walk1?	No	N/A	Painted X Walk2?	N/A
	X Walk 1 Direction	To N		X Walk 2 Direction	N/A
N/A	X Walk 1 Width (in)	N/A	N/A	X Walk 2 Width (in)	N/A
	X Walk 1 Slope (%)	6.0		X Walk 2 Slope (%)	N/A
	X Walk 1 X Slope (%)	0.1		X Walk 2 X Slope (%)	N/A

N/A	Ramp inside XWalk1?	N/A	N/A	Ramp inside XWalk2?	N/A
	Road Slope (%)	N/A	N/A	Clear Space?	N/A
	Road X Slope (%)	N/A	N/A	Clear Space to XWalk (in)	N/A
N/A	Any Obstructions?	N/A	N/A	Storm Grate/Utility Hazard?	N/A
	Obstruction Type			Storm Grate/Utility Type	
		N/A			N/A
		No		Surface Condition? (G/P)	Poor

Remove & Replace Entire Ramp.
