# Access Compliance Report

## Public Rights-of-Way (Curb Ramps)

| Intersection ID: 10038861 | Main Street: STERLING_RD | Cross Street: N/A | Location: SW |
| ADA ID: CFF5C507A109 | Ramp Type: BlendTrans1 | Initial Pass/Fail: Pass | Overall Compliance: No |

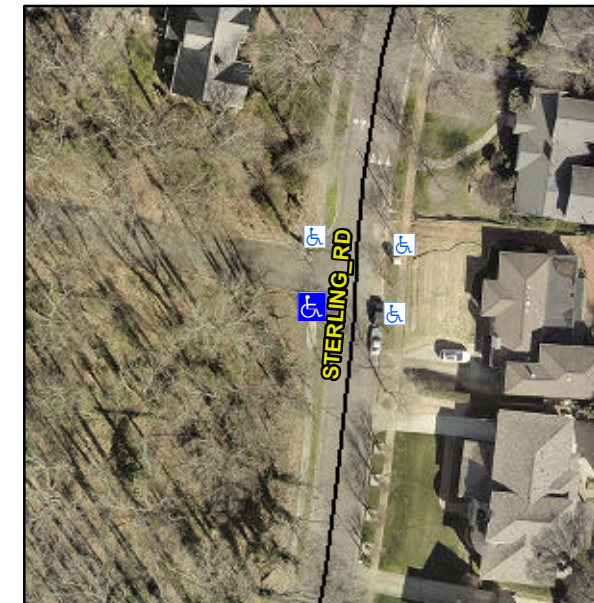
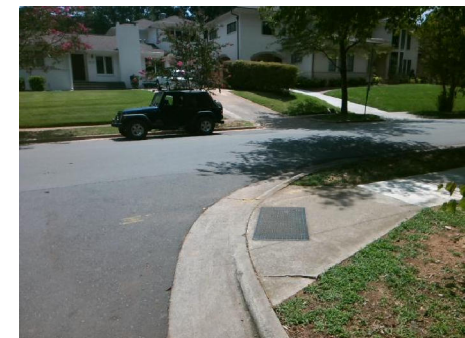
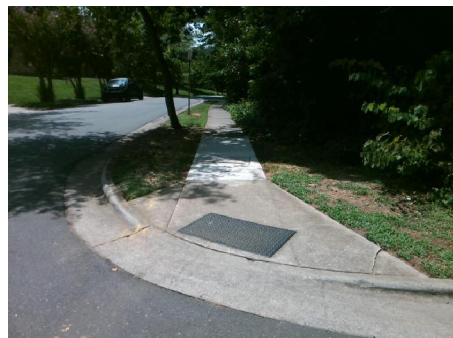
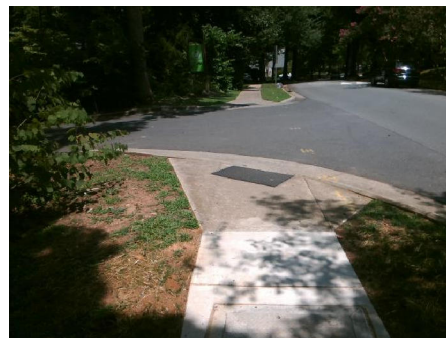
**R304.5.3, R304.2.1, R305.2**

| Compliance | Description | Data | Compliance | Description | Data |
|---|---|---|---|---|---|
| Yes | Ramp Width (in) | 55.0 | No | BlendTrans XSlope (%) | 3.8 |
| No | Landing Length (in) | 37.5 | Yes | DWS Provided? | Yes |
| N/A | Landing Curb? (Y/N) | No | No | DWS Offset (in) | 5.0 |
| Yes | Gutter Lip Ht (in) | 0.0 | No | Gutter X Slope (%) | 2.6 |

**Remove & Replace Curb Ramp With Two New Directional Ramps or Equivalent. Remove & Replace Gutter.**
