# Access Compliance Report

## Public Rights-of-Way

| Intersection ID: 13787 | Main Street: CHARLOTTETOWNE_AV | Cross Street: E_4TH_ST | Location: | N |
| ADA ID: CFF896677550 | Ramp Type: Perp | Initial Pass/Fail: Pass | Overall Compliance: No | Severity Score: 7.75 |

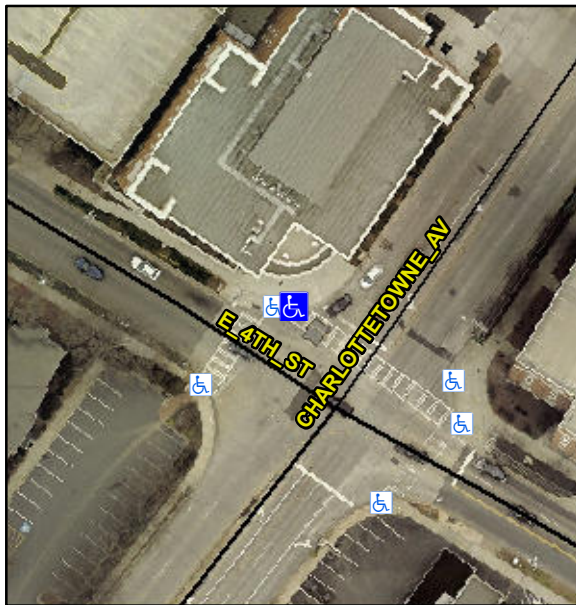
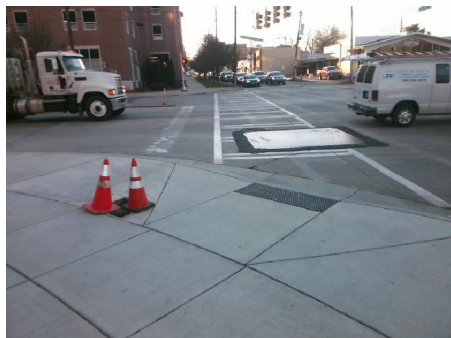
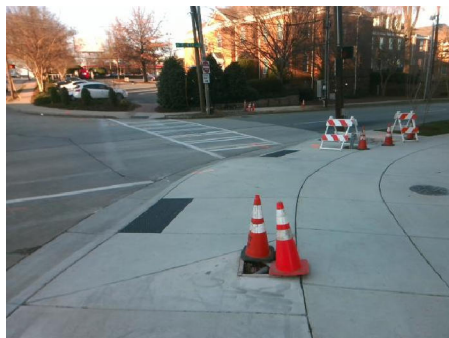
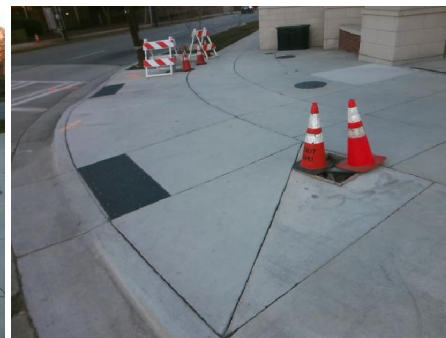
**Not Found, R304.5.3, R304.2.3,  
R304.5.4**

| Compliance | Description | Data | Compliance | Description | Data |
|---|---|---|---|---|---|
| Yes | Ramp Width (in) | 60.0 | No | Ramp XSlope (%) | 3.1 |
| N/A | Flare Slope LT (%) | 4.8 | No | Flare Slope RT (%) | 10.4 |
| Yes | Gutter Ponding? | No | No | Gutter Slope (%) | 6.6 |

**Remove & Replace Entire Ramp.  
Remove & Replace Gutter.**
