# Access Compliance Report

## Public Rights-of-Way

### (Curb Ramps)

Intersection ID: 8857	Main Street: DORTON_ST	Cross Street: N_TRYON_ST	Location: SE
ADA ID: D0005C8B8102	Ramp Type: Perp	Initial Pass/Fail: Fail	Overall Compliance: No
Severity Score: 10			
Codes/Mitigation Info/Possible Solution		Field Measurements/Component Compliance

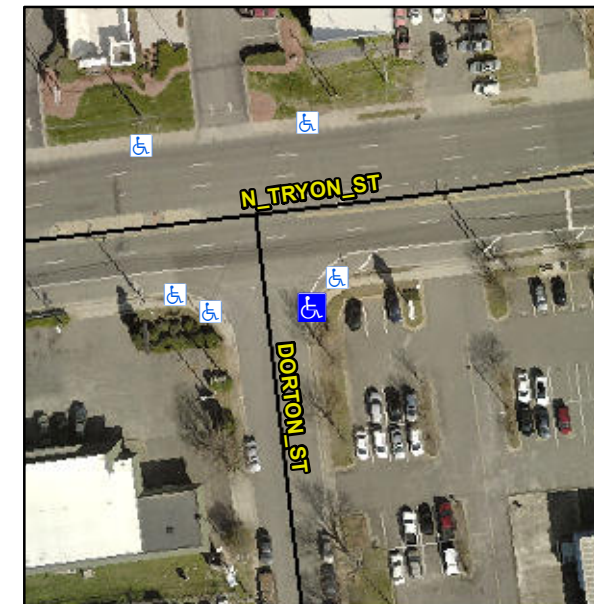
Compliance	Description	Data	Compliance	Description	Data
N/A	Ramp Length (in)	55.0	Yes	Ramp Slope (%)	7.8
No	Ramp Width (in)	47.0	No	Ramp XSlope (%)	3.0
N/A	Flare Type LT	N/A	N/A	Flare Type RT	N/A
N/A	Flare Slope LT (%)	N/A	N/A	Flare Slope RT (%)	N/A
N/A	Flare Traversable LT?	N/A	N/A	Flare Traversable RT?	N/A
N/A	Landing Length (in)	N/A	N/A	DWS Provided?	N/A
N/A	Landing Width (in)	N/A	N/A	DWS Contrast?	N/A
N/A	Landing Slope (%)	N/A	N/A	DWS Length (in)	N/A
N/A	Landing X Slope (%)	N/A	N/A	DWS Full Width?	N/A
N/A	Landing Curb? (Y/N)	N/A	N/A	DWS Offset (in)	N/A
N/A	Shared Landing?	N/A			
N/A	Gutter Ponding?	N/A	N/A	Gutter Slope (%)	N/A
N/A	Gutter Lip Ht (in)	1.0	N/A	Gutter X Slope (%)	N/A
N/A	Painted X Walk1?	No	N/A	Painted X Walk2?	N/A
	X Walk 1 Direction	To W		X Walk 2 Direction	N/A
N/A	X Walk 1 Width (in)	N/A	N/A	X Walk 2 Width (in)	N/A
	X Walk 1 Slope (%)	0.7		X Walk 2 Slope (%)	N/A
	X Walk 1 X Slope (%)	4.0		X Walk 2 X Slope (%)	N/A

N/A	Ramp inside XWalk1?	N/A	N/A	Ramp inside XWalk2?	N/A
	Road Slope (%)	N/A	N/A	Clear Space?	N/A
	Road X Slope (%)	N/A	N/A	Clear Space to XWalk (in)	N/A
N/A	Any Obstructions?	N/A	N/A	Storm Grate/Utility Hazard?	N/A
	Obstruction Type			Storm Grate/Utility Type	
		N/A			N/A
			Yes	Surface Condition? (G/P)	Good

Possible Solutions:

**Remove & Replace Entire Ramp.**
