Access Compliance Report

Public Rights-of-Way

(Curb Ramps)

Intersection ID: 13817	Main Street: SHENANDOAH_AV	Cross Street: WESTOVER_ST	Location:	N
ADA ID: D00EEDD97E25	Ramp Type: PerpDiag	Initial Pass/Fail: Fail	Overall Compliance: No	Severity Score: 21.25

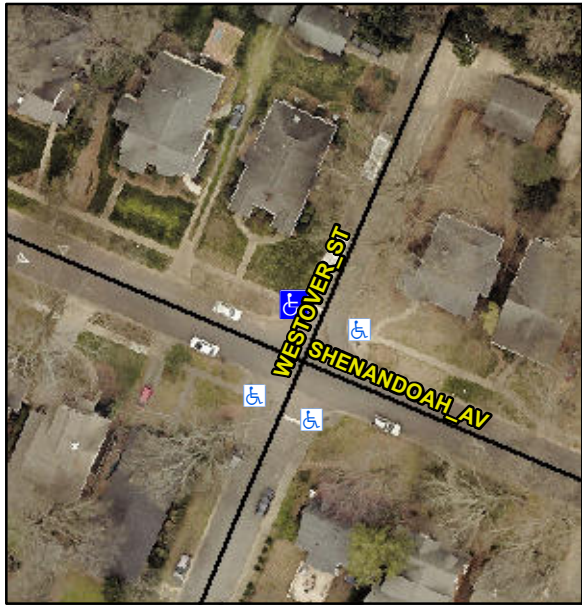
Possible Solutions:		Compliance	Description	Data	Compliance	Description	Data
	Remove & Replace Curb Ramp With Two New Directional Ramps or Equivalent.		N/A	Ramp Length (in)	60.0	No	Ramp Slope (%)	9.3
			No	Ramp Width (in)	36.0	Yes	Ramp XSlope (%)	0.2
			N/A	Flare Type LT	N/A	N/A	Flare Type RT	N/A
			N/A	Flare Slope LT (%)	N/A	N/A	Flare Slope RT (%)	N/A
			N/A	Flare Traversable LT?	N/A	N/A	Flare Traversable RT?	N/A
			N/A	Landing Length (in)	N/A	N/A	DWS Provided?	N/A
			N/A	Landing Width (in)	N/A	N/A	DWS Contrast?	N/A
			N/A	Landing Slope (%)	N/A	N/A	DWS Length (in)	N/A
			N/A	Landing X Slope (%)	N/A	N/A	DWS Full Width?	N/A
Surveyor Notes:			N/A	Landing Curb? (Y/N)	N/A	N/A	DWS Offset (in)	N/A
N/A			N/A	Shared Landing?	N/A			
PROW/ADA:			N/A	Gutter Ponding?	N/A	N/A	Gutter Slope (%)	N/A
R304.5.1, R304.2.2			N/A	Gutter Lip Ht (in)	1.0	N/A	Gutter X Slope (%)	N/A

N/A	Painted X Walk1?	No	N/A	Painted X Walk2?	No
				X Walk 1 Direction	To SW		X Walk 2 Direction	To SE
			N/A	X Walk 1 Width (in)	N/A	N/A	X Walk 2 Width (in)	N/A
				X Walk 1 Slope (%)	0.2		X Walk 2 Slope (%)	0.8
				X Walk 1 X Slope (%)	1.4		X Walk 2 X Slope (%)	0.7
			N/A	Ramp inside XWalk1?	N/A	N/A	Ramp inside XWalk2?	N/A
				Road Slope (%)	0.4	N/A	Clear Space?	N/A
				Road X Slope (%)	1.6	N/A	Clear Space to XWalk (in)	N/A
			N/A	Any Obstructions?	N/A	N/A	Storm Grate/Utility Hazard?	N/A
				Obstruction Type			Storm Grate/Utility Type	
					N/A			N/A
						Yes	Surface Condition? (G/P)	Good
