Access Compliance Report

Public Rights-of-Way

(Curb Ramps)

Intersection ID: 47400	Main Street: OVERLAND_PARK_LN	Cross Street: FLAT_RIVER_DR	Location:	E
ADA ID: D014107BDA2D	Ramp Type: Directional1	Initial Pass/Fail: Fail	Overall Compliance: No	Severity Score: 12.5
Codes/Mitigation Info/Possible Solution		Field Measurements/Component Compliance

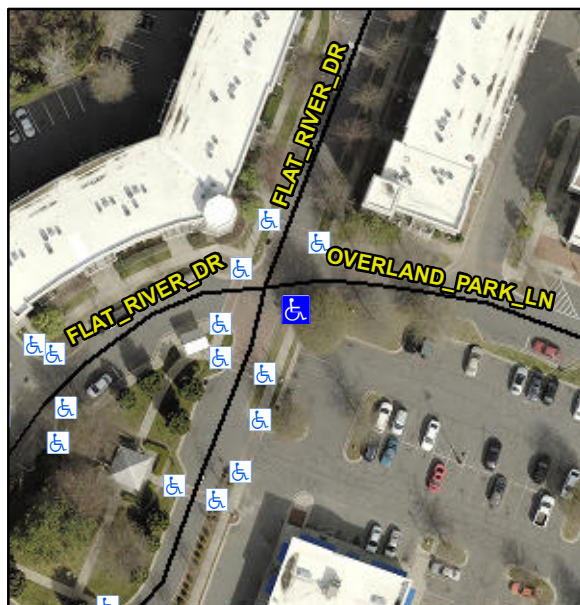
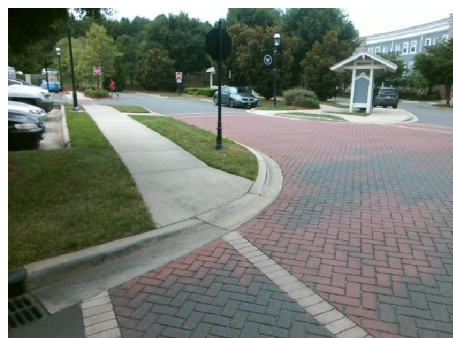
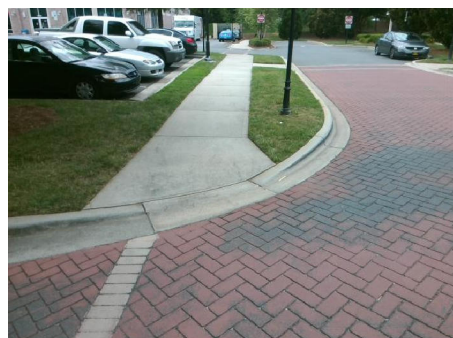
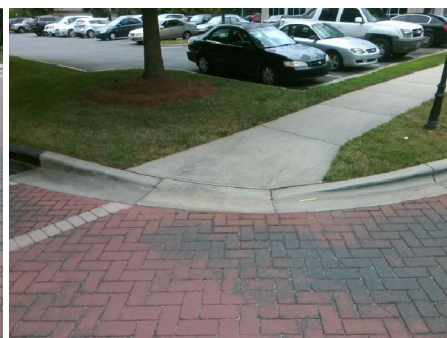
R304.2.2

Compliance	Description	Data	Compliance	Description	Data
N/A	Ramp Length (in)	45.0	N/A	Grade Break?	N/A
Yes	Ramp Width (in)	51.0	N/A	Grade Break Slope (%)	0.0
No	Ramp Slope (%)	10.3	N/A	Grade Break XSlope (%)	0.0
Yes	Ramp XSlope (%)	0.3			
N/A	Flare Type LT	N/A	N/A	Flare Type RT	N/A
N/A	Flare Slope LT (%)	N/A	N/A	Flare Slope RT (%)	0.0
N/A	Flare Traversable LT?	N/A	N/A	Flare Traversable RT?	N/A
N/A	Landing Length (in)	0.0	N/A	DWS Provided?	N/A
N/A	Landing Width (in)	0.0	N/A	DWS Contrast?	N/A
N/A	Landing Slope (%)	0.0	N/A	DWS Length (in)	N/A
N/A	Landing X Slope (%)	0.0	N/A	DWS Full Width?	N/A
N/A	Landing Curb? (Y/N)	N/A	N/A	DWS Offset LT (in)	N/A
N/A	Shared Landing?	N/A	N/A	DWS Offset RT (in)	N/A
N/A	Gutter Ponding?	0.0	N/A	Gutter Slope (%)	N/A
N/A	Gutter Lip Ht (in)	0.0	N/A	Gutter X Slope (%)	N/A
N/A	Painted X Walk1?	No		Road Slope (%)	0.2
	X Walk 1 Direction	To NE		Road X Slope (%)	2.1
	X Walk 1 Width (in)	N/A		Clear Space?	N/A

X Walk 1 Slope (%)	0.2	N/A	Clear Space to XWalk (in)	N/A
	X Walk 1 X Slope (%)	2.1	N/A	Storm Grate/Utility Hazard?	N/A
N/A	Ramp inside XWalk1?	N/A		Storm Grate/Utility Type	
N/A	Any Obstructions?	N/A			N/A
	Obstruction Type		Yes	Surface Condition? (G/P)	Good
			N/A	Curb Slope (%)	N/A

Possible Solutions:

Remove & Replace Entire Ramp.

Total Cost: \$ 1600.00
