Intersection ID: 31701	Main Street: ATLAS_CEDAR_DR	Cross Street: CAROLINA_LAUREL_CT	Location:	SW
ADA ID: D016020ECC20	Ramp Type: PerpDiag	Initial Pass/Fail: Fail	Overall Compliance: No	Severity Score: 18.75

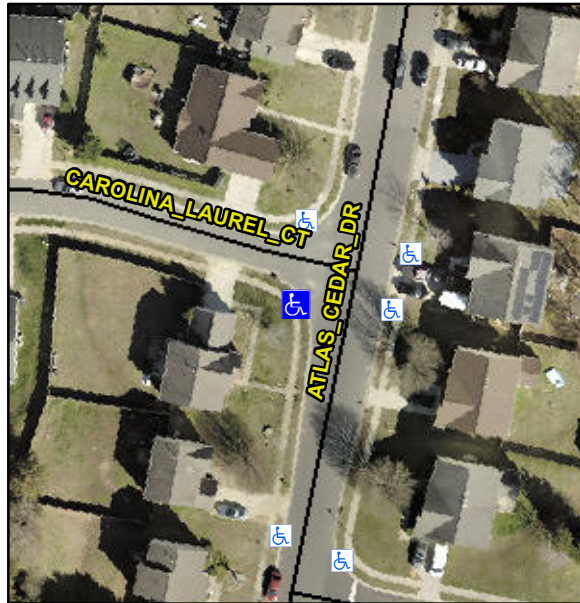
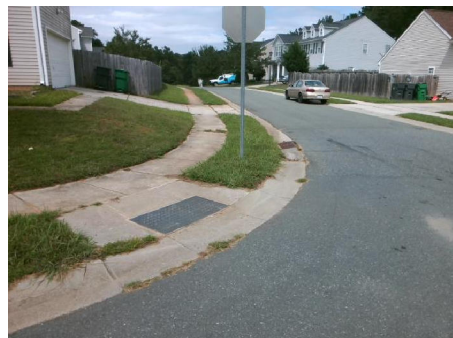
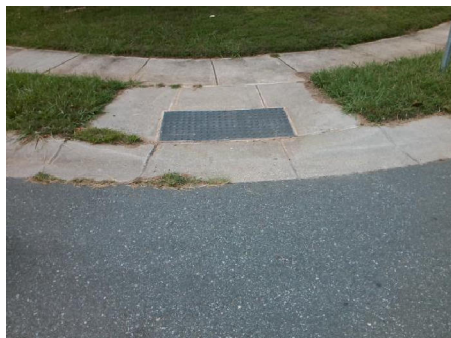
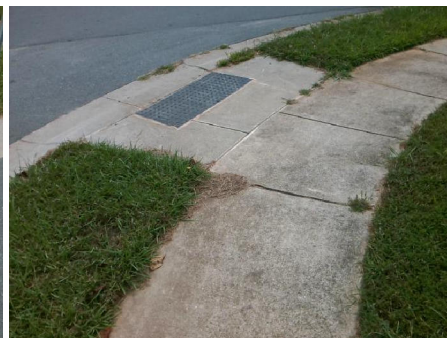
**Not Found, R304.5.1, R304.5.3**

Compliance	Description	Data	Compliance	Description	Data
N/A	Ramp Length (in)	48.0	Yes	Ramp Slope (%)	5.9
No	Ramp Width (in)	35.0	No	Ramp XSlope (%)	2.6
N/A	Flare Type LT	N/A	N/A	Flare Type RT	N/A
N/A	Flare Slope LT (%)	N/A	N/A	Flare Slope RT (%)	N/A
N/A	Flare Traversable LT?	N/A	N/A	Flare Traversable RT?	N/A
N/A	Landing Length (in)	N/A	N/A	DWS Provided?	N/A
N/A	Landing Width (in)	N/A	N/A	DWS Contrast?	N/A
N/A	Landing Slope (%)	N/A	N/A	DWS Length (in)	N/A
N/A	Landing X Slope (%)	N/A	N/A	DWS Full Width?	N/A
N/A	Landing Curb? (Y/N)	N/A	N/A	DWS Offset (in)	N/A
N/A	Shared Landing?	N/A			
N/A	Gutter Ponding?	N/A	N/A	Gutter Slope (%)	N/A
N/A	Gutter Lip Ht (in)	N/A	N/A	Gutter X Slope (%)	N/A
N/A	Painted X Walk1?	No	N/A	Painted X Walk2?	No
	X Walk 1 Direction	To E		X Walk 2 Direction	To N
N/A	X Walk 1 Width (in)	N/A	N/A	X Walk 2 Width (in)	N/A
	X Walk 1 Slope (%)	3.4		X Walk 2 Slope (%)	0.4
	X Walk 1 X Slope (%)	2.2		X Walk 2 X Slope (%)	2.1

N/A	Ramp inside XWalk1?	N/A	N/A	Ramp inside XWalk2?	N/A
	Road Slope (%)	0.6	N/A	Clear Space?	N/A
	Road X Slope (%)	5.3	N/A	Clear Space to XWalk (in)	N/A
N/A	Any Obstructions?	N/A	N/A	Storm Grate/Utility Hazard?	N/A
	Obstruction Type			Storm Grate/Utility Type	
		N/A			N/A
			Yes	Surface Condition? (G/P)	Good

**Remove & Replace Curb Ramp With Two New Directional Ramps or Equivalent.**

Total Cost: \$ 3200.00
