Access Compliance Report

Public Rights-of-Way

(Curb Ramps)

Intersection ID: 10025885	Main Street: ELIZABETH_AV	Cross Street: N/A	Location: N
ADA ID: D01645E4FB96	Ramp Type: Perp	Initial Pass/Fail: Fail	Overall Compliance: No
Severity Score: 13.75			
Codes/Mitigation Info/Possible Solution		Field Measurements/Component Compliance

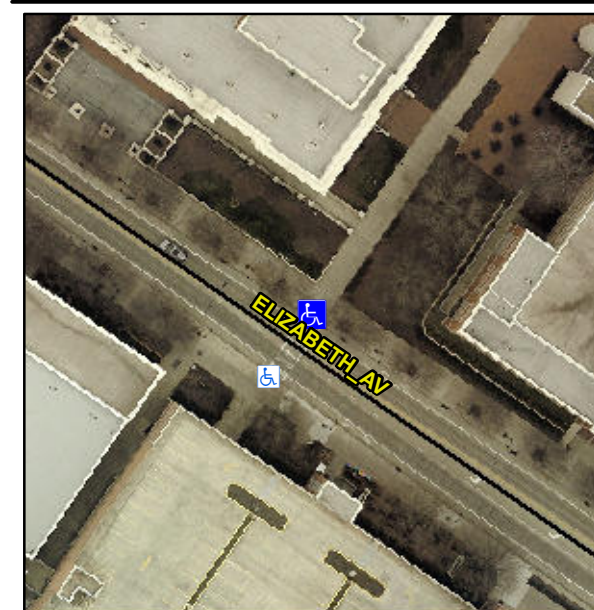
Not Found, R304.2.2, R304.5.3

Compliance	Description	Data	Compliance	Description	Data
N/A	Ramp Length (in)	84.5	No	Ramp Slope (%)	8.8
Yes	Ramp Width (in)	96.0	No	Ramp XSlope (%)	3.4
N/A	Flare Type LT	N/A	N/A	Flare Type RT	N/A
N/A	Flare Slope LT (%)	N/A	N/A	Flare Slope RT (%)	N/A
N/A	Flare Traversable LT?	N/A	N/A	Flare Traversable RT?	N/A
N/A	Landing Length (in)	N/A	N/A	DWS Provided?	N/A
N/A	Landing Width (in)	N/A	N/A	DWS Contrast?	N/A
N/A	Landing Slope (%)	N/A	N/A	DWS Length (in)	N/A
N/A	Landing X Slope (%)	N/A	N/A	DWS Full Width?	N/A
N/A	Landing Curb? (Y/N)	N/A	N/A	DWS Offset (in)	N/A
N/A	Shared Landing?	N/A			
N/A	Gutter Ponding?	N/A	N/A	Gutter Slope (%)	N/A
N/A	Gutter Lip Ht (in)	N/A	N/A	Gutter X Slope (%)	N/A
N/A	Painted X Walk1?	Yes	N/A	Painted X Walk2?	N/A
	X Walk 1 Direction	To SW		X Walk 2 Direction	N/A
N/A	X Walk 1 Width (in)	110.0	N/A	X Walk 2 Width (in)	N/A
	X Walk 1 Slope (%)	0.5		X Walk 2 Slope (%)	N/A
	X Walk 1 X Slope (%)	3.1		X Walk 2 X Slope (%)	N/A

N/A	Ramp inside XWalk1?	Yes	N/A	Ramp inside XWalk2?	N/A
	Road Slope (%)	N/A	N/A	Clear Space?	N/A
	Road X Slope (%)	N/A	N/A	Clear Space to XWalk (in)	N/A
N/A	Any Obstructions?	N/A	N/A	Storm Grate/Utility Hazard?	N/A
	Obstruction Type			Storm Grate/Utility Type	
		N/A			N/A
			Yes	Surface Condition? (G/P)	Good

Possible Solutions:

Remove & Replace Entire Ramp.
