# Access Compliance Report

## Public Rights-of-Way

| Intersection ID: 2949 | Main Street: DOWNFIELD_WOOD_DR | Cross Street: LADY_BANK_DR | Location: | N |
| ADA ID: D02734D730AB | Ramp Type: Perp | Initial Pass/Fail: Fail | Overall Compliance: No | Severity Score: 22.5 |

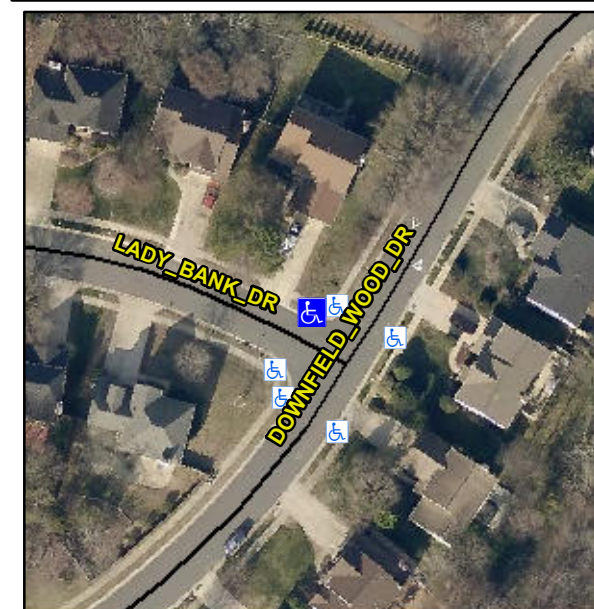
**R304.5.1, R304.2.2, R304.5.3**

| Compliance | Description | Data | Compliance | Description | Data |
|---|---|---|---|---|---|
| N/A | Ramp Length (in) | 49.0 | No | Ramp Slope (%) | 11.1 |
| No | Ramp Width (in) | 47.0 | No | Ramp XSlope (%) | 4.7 |

**Remove & Replace Entire Ramp.**

Total Cost: \$ 1850.00
