# Access Compliance Report

## Public Rights-of-Way

### (Curb Ramps)

Intersection ID: 13197	Main Street: S_MCDOWELL_ST	Cross Street: E_4TH_ST	Location: E
ADA ID: D038F0578A1F	Ramp Type: Directional	Initial Pass/Fail: Pass	Overall Compliance: No
Severity Score: 5			
Codes/Mitigation Info/Possible Solution		Field Measurements/Component Compliance

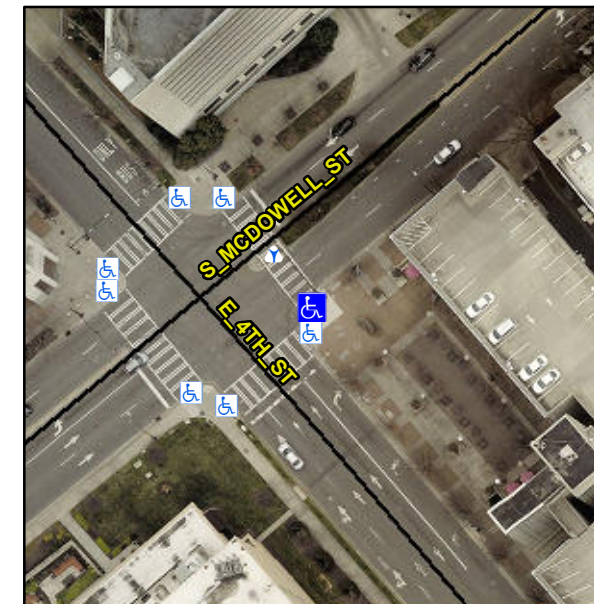
Compliance	Description	Data	Compliance	Description	Data
N/A	Ramp Length (in)	45.0	Yes	Grade Break?	Yes
Yes	Ramp Width (in)	51.0	Yes	Grade Break Slope (%)	4.7
Yes	Ramp Slope (%)	5.5	Yes	Grade Break XSlope (%)	1.2
Yes	Ramp XSlope (%)	0.6			
No	Flare Type LT	N/A	N/A	Flare Type RT	N/A
N/A	Flare Slope LT (%)	N/A	Yes	Flare Slope RT (%)	7.6
N/A	Flare Traversable LT?	No	N/A	Flare Traversable RT?	Yes
Yes	Landing Length (in)	48.0	Yes	DWS Provided?	Yes
Yes	Landing Width (in)	51.0	Yes	DWS Contrast?	Yes
Yes	Landing Slope (%)	0.3	Yes	DWS Length (in)	24.0
Yes	Landing X Slope (%)	1.0	Yes	DWS Full Width?	Yes
N/A	Landing Curb? (Y/N)	N/A	Yes	DWS Offset LT (in)	30.0
N/A	Shared Landing?	No	Yes	DWS Offset RT (in)	1.0
Yes	Gutter Ponding?	No	Yes	Gutter Slope (%)	0.8
Yes	Gutter Lip Ht (in)	0.0	Yes	Gutter X Slope (%)	1.6
N/A	Painted X Walk1?	Yes		Road Slope (%)	0.8
	X Walk 1 Direction	To NW		Road X Slope (%)	2.7
	X Walk 1 Width (in)	150.0		Clear Space?	Yes

X Walk 1 Slope (%)	0.8	N/A	Clear Space to XWalk (in)	N/A
	X Walk 1 X Slope (%)	2.7	Yes	Storm Grate/Utility Hazard?	No
Yes	Ramp inside XWalk1?	Yes		Storm Grate/Utility Type	
Yes	Any Obstructions?	No			N/A
	Obstruction Type		Yes	Surface Condition? (G/P)	Good
			N/A	Curb Slope (%)	1.4

Possible Solutions:

**Remove & Replace Curbed Edge.**

**R304.2.3**

\$ 300.00
