Access Compliance Report

Public Rights-of-Way

(Curb Ramps)

Intersection ID: 23437	Main Street: MOSS_RD	Cross Street: S_TRYON_ST	Location: SE
ADA ID: D0390D317D0E	Ramp Type: Perp	Initial Pass/Fail: Fail	Overall Compliance: No
Severity Score: 30			
Codes/Mitigation Info/Possible Solution		Field Measurements/Component Compliance

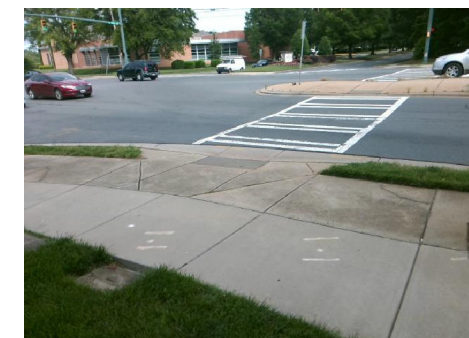
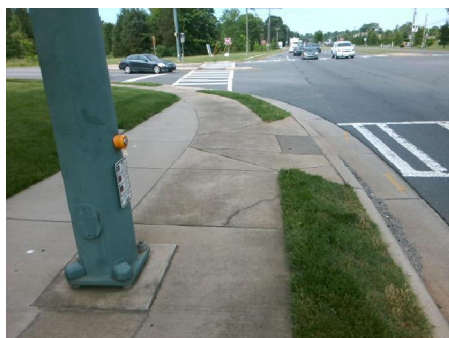
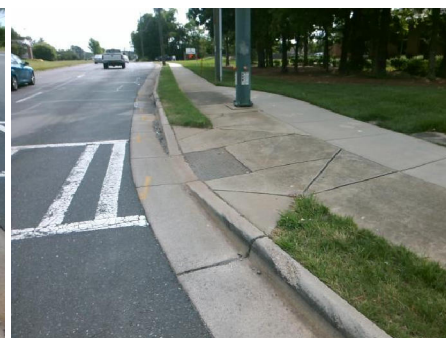
Compliance	Description	Data	Compliance	Description	Data
N/A	Ramp Length (in)	90.0	Yes	Ramp Slope (%)	7.4
No	Ramp Width (in)	35.0	No	Ramp XSlope (%)	5.7
N/A	Flare Type LT	N/A	N/A	Flare Type RT	N/A
N/A	Flare Slope LT (%)	N/A	N/A	Flare Slope RT (%)	N/A
N/A	Flare Traversable LT?	N/A	N/A	Flare Traversable RT?	N/A
N/A	Landing Length (in)	N/A	N/A	DWS Provided?	N/A
N/A	Landing Width (in)	N/A	N/A	DWS Contrast?	N/A
N/A	Landing Slope (%)	N/A	N/A	DWS Length (in)	N/A
N/A	Landing X Slope (%)	N/A	N/A	DWS Full Width?	N/A
N/A	Landing Curb? (Y/N)	N/A	N/A	DWS Offset (in)	N/A
N/A	Shared Landing?	N/A			
N/A	Gutter Ponding?	N/A	N/A	Gutter Slope (%)	N/A
N/A	Gutter Lip Ht (in)	N/A	N/A	Gutter X Slope (%)	N/A
N/A	Painted X Walk1?	Yes	N/A	Painted X Walk2?	N/A
	X Walk 1 Direction	To N		X Walk 2 Direction	N/A
N/A	X Walk 1 Width (in)	121.0	N/A	X Walk 2 Width (in)	N/A
	X Walk 1 Slope (%)	0.6		X Walk 2 Slope (%)	N/A
	X Walk 1 X Slope (%)	1.4		X Walk 2 X Slope (%)	N/A

N/A	Ramp inside XWalk1?	Yes	N/A	Ramp inside XWalk2?	N/A
	Road Slope (%)	N/A	N/A	Clear Space?	N/A
	Road X Slope (%)	N/A	N/A	Clear Space to XWalk (in)	N/A
N/A	Any Obstructions?	N/A	N/A	Storm Grate/Utility Hazard?	N/A
	Obstruction Type			Storm Grate/Utility Type	
		N/A			N/A
			Yes	Surface Condition? (G/P)	Good

Remove & Replace Entire Ramp.
