Access Compliance Report

Public Rights-of-Way

(Curb Ramps)

Intersection ID: 10022359	Main Street: CAMERON_VALLEY_PY	Cross Street: N/A	Location: NW
ADA ID: D0392CF86D98	Ramp Type: PerpDiag	Initial Pass/Fail: Fail	Overall Compliance: No Severity Score: 13.75

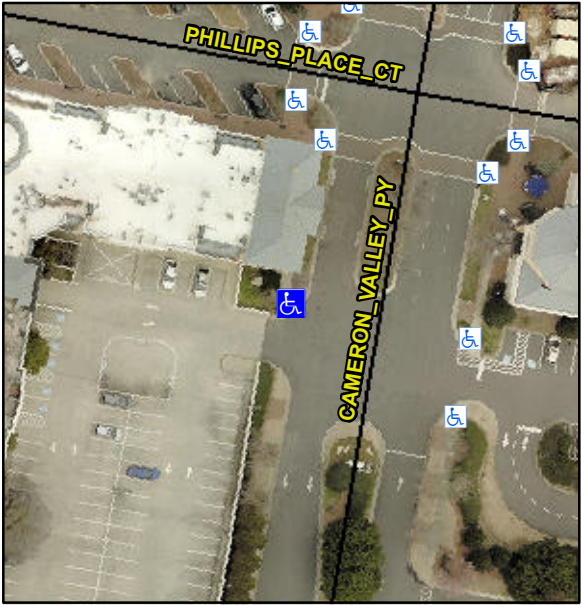
Possible Solutions:		Compliance	Description	Data
	Remove & Replace Curb Ramp With Two New Directional Ramps or Equivalent.		No	Ramp Length (in)	53.0
			Yes	Ramp Width (in)	53.0
			N/A	Flare Type LT	N/A
			N/A	Flare Slope LT (%)	N/A
			N/A	Flare Traversable LT?	N/A
			N/A	Landing Length (in)	N/A
			N/A	Landing Width (in)	N/A
			N/A	Landing Slope (%)	N/A
			N/A	Landing X Slope (%)	N/A
<p>Surveyor Notes:</p> <p>N/A</p> <p>PROW/ADA:</p> <p>Not Found, R304.2.2, R304.5.3</p>			N/A	Flare Type RT	N/A
			N/A	Flare Slope RT (%)	N/A
			N/A	Flare Traversable RT?	N/A
			N/A	DWS Provided?	N/A
			N/A	DWS Contrast?	N/A
			N/A	DWS Length (in)	N/A
			N/A	DWS Full Width?	N/A
			N/A	DWS Offset (in)	N/A
			N/A	Shared Landing?	N/A
			N/A	Gutter Ponding?	N/A
			N/A	Gutter Lip Ht (in)	N/A
			N/A	Painted X Walk1?	No
				X Walk 1 Direction	To S
			N/A	X Walk 1 Width (in)	N/A

X Walk 1 Slope (%)	2.2
				X Walk 1 X Slope (%)	4.3
			N/A	Ramp inside XWalk1?	N/A
				Road Slope (%)	4.4
				Road X Slope (%)	0.6
			N/A	Any Obstructions?	N/A
				Obstruction Type	
Total Cost:		\$ 3200.00			
Street 1 Name	N/A				
Stop Condition-Street 2	StopSign				
Street 2 Name	CAMERON VALLEY PY				
Stop Condition-Street 1	None
