Access Compliance Report

Public Rights-of-Way

(Curb Ramps)

Intersection ID: 25053	Main Street: COTTON_CREEK_DR	Cross Street: TRUSCOTT_RD	Location: W
ADA ID: D0460FB33C13	Ramp Type: PerpDiag	Initial Pass/Fail: Fail	Overall Compliance: No
Severity Score: 35			
Codes/Mitigation Info/Possible Solution		Field Measurements/Component Compliance

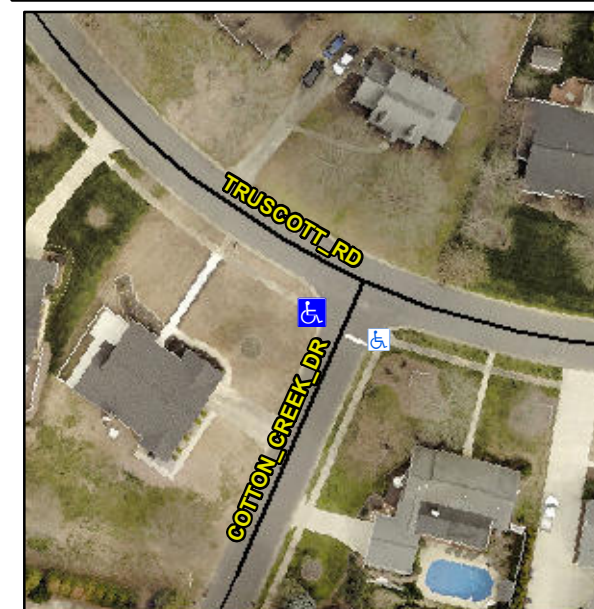
Not Found, R304.5.1, R304.2.2, R304.5.3

Compliance	Description	Data	Compliance	Description	Data
N/A	Ramp Length (in)	135.0	No	Ramp Slope (%)	12.2
No	Ramp Width (in)	47.5	No	Ramp XSlope (%)	4.0
N/A	Flare Type LT	N/A	N/A	Flare Type RT	N/A
N/A	Flare Slope LT (%)	N/A	N/A	Flare Slope RT (%)	N/A
N/A	Flare Traversable LT?	N/A	N/A	Flare Traversable RT?	N/A
N/A	Landing Length (in)	N/A	N/A	DWS Provided?	N/A
N/A	Landing Width (in)	N/A	N/A	DWS Contrast?	N/A
N/A	Landing Slope (%)	N/A	N/A	DWS Length (in)	N/A
N/A	Landing X Slope (%)	N/A	N/A	DWS Full Width?	N/A
N/A	Landing Curb? (Y/N)	N/A	N/A	DWS Offset (in)	N/A
N/A	Shared Landing?	N/A			
N/A	Gutter Ponding?	N/A	N/A	Gutter Slope (%)	N/A
N/A	Gutter Lip Ht (in)	N/A	N/A	Gutter X Slope (%)	N/A
N/A	Painted X Walk1?	No	N/A	Painted X Walk2?	No
	X Walk 1 Direction	To SE		X Walk 2 Direction	To NE
N/A	X Walk 1 Width (in)	N/A	N/A	X Walk 2 Width (in)	N/A
	X Walk 1 Slope (%)	2.1		X Walk 2 Slope (%)	6.2
	X Walk 1 X Slope (%)	6.5		X Walk 2 X Slope (%)	1.8

N/A	Ramp inside XWalk1?	N/A	N/A	Ramp inside XWalk2?	N/A
	Road Slope (%)	4.2	N/A	Clear Space?	N/A
	Road X Slope (%)	4.2	N/A	Clear Space to XWalk (in)	N/A
N/A	Any Obstructions?	N/A	N/A	Storm Grate/Utility Hazard?	N/A
	Obstruction Type			Storm Grate/Utility Type	
		N/A			N/A
			Yes	Surface Condition? (G/P)	Good

Possible Solutions:

Remove & Replace Curb Ramp With Two New Directional Ramps or Equivalent.
