Access Compliance Report

Public Rights-of-Way

(Curb Ramps)

Intersection ID: 15242	Main Street: E_INDEPENDENCE_BV	Cross Street: N_WENDOVER_RD_RA	Location: NW
ADA ID: D0472D98CE2C	Ramp Type: Perp	Initial Pass/Fail: Fail	Overall Compliance: No
			Severity Score: 21.25

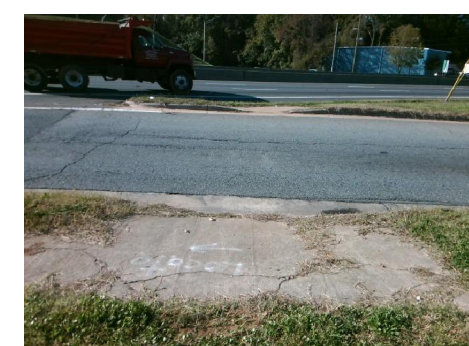
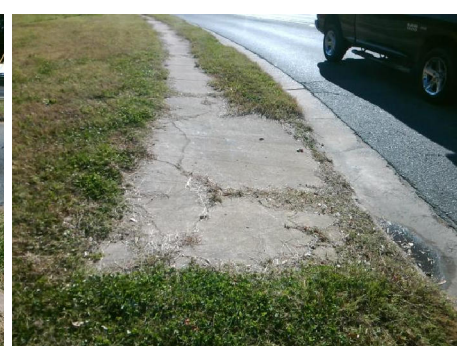
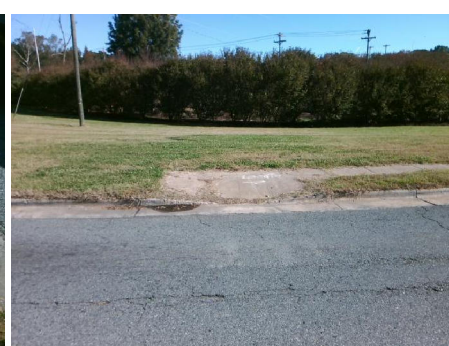
Possible Solutions:		Compliance	Description	Data	Compliance	Description	Data
	Remove & Replace Entire Ramp.		N/A	Ramp Length (in)	80.0	No	Ramp Slope (%)	11.0
			No	Ramp Width (in)	38.0	Yes	Ramp XSlope (%)	0.6
			N/A	Flare Type LT	N/A	N/A	Flare Type RT	N/A
			N/A	Flare Slope LT (%)	N/A	N/A	Flare Slope RT (%)	N/A
			N/A	Flare Traversable LT?	N/A	N/A	Flare Traversable RT?	N/A
			N/A	Landing Length (in)	N/A	N/A	DWS Provided?	N/A
			N/A	Landing Width (in)	N/A	N/A	DWS Contrast?	N/A
			N/A	Landing Slope (%)	N/A	N/A	DWS Length (in)	N/A
			N/A	Landing X Slope (%)	N/A	N/A	DWS Full Width?	N/A
Surveyor Notes:			N/A	Landing Curb? (Y/N)	N/A	N/A	DWS Offset (in)	N/A
N/A			N/A	Shared Landing?	N/A			
PROW/ADA:			N/A	Gutter Ponding?	N/A	N/A	Gutter Slope (%)	N/A
Not Found, R304.5.1, R304.2.2			N/A	Gutter Lip Ht (in)	N/A	N/A	Gutter X Slope (%)	N/A

N/A	Painted X Walk1?	No	N/A	Painted X Walk2?	N/A
				X Walk 1 Direction	To SW		X Walk 2 Direction	N/A
			N/A	X Walk 1 Width (in)	N/A	N/A	X Walk 2 Width (in)	N/A
				X Walk 1 Slope (%)	7.4		X Walk 2 Slope (%)	N/A
				X Walk 1 X Slope (%)	0.5		X Walk 2 X Slope (%)	N/A
			N/A	Ramp inside XWalk1?	N/A	N/A	Ramp inside XWalk2?	N/A
				Road Slope (%)	N/A	N/A	Clear Space?	N/A
				Road X Slope (%)	N/A	N/A	Clear Space to XWalk (in)	N/A
			N/A	Any Obstructions?	N/A	N/A	Storm Grate/Utility Hazard?	N/A
				Obstruction Type			Storm Grate/Utility Type	
					N/A			N/A
						Yes	Surface Condition? (G/P)	Good
Total Cost:		\$ 1850.00						
Street 1 Name		N WENDOVER RD RA						
Stop Condition-Street 2		None						
Street 2 Name		N/A						
Stop Condition-Street 1		N/A
