Access Compliance Report Public Rights-of-Way (Curb Ramps)

Intersection ID: 47914 Main Street: MEARN_RD Cross Street: ROOK_RD Location: W **Overall Compliance: No** ADA ID: D04FD6040119 Ramp Type: Perp Initial Pass/Fail: Fail **Severity Score:** 12.5

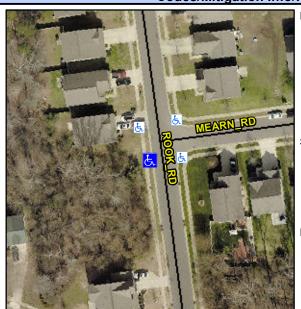
i ossible solution		i icia ivic		
Possible Solutions:	Compl	iance Description		
Remove & Replace Entire Ramp.	N/A	Ramp Length (in)		
·	Yes	Ramp Width (in)		
	N/A	Flare Type LT		
	N/A	Flare Slope LT (%)		
	N/A	Flare Traversable L		
	N/A	Landing Length (in)		
Surveyor Notes:	N/A	Landing Width (in)		
N/A	N/A	Landing Slope (%)		
	N/A	Landing X Slope (%)		
	N/A	Landing Curb? (Y/N)		
	N/A	Shared Landing?		
PROW/ADA:	N/A	Gutter Ponding?		
Not Found, R304.2.2	N/A	Gutter Lip Ht (in)		
	N/A	Painted X Walk1?		
		X Walk 1 Direction		
	N/A	X Walk 1 Width (in)		
		X Walk 1 Slope (%)		
		X Walk 1 X Slope (%		
	N/A	Ramp inside XWalk1		
		Road Slope (%)

- CART - +	PRO	W/ADA:			N/A	Gutter Ponding?	N/A	N/A	Gutter Slope (%)	N/A
	No	t Found, R304.2.2			N/A	Gutter Lip Ht (in)	N/A	N/A	Gutter X Slope (%)	N/A
	The second second	,			N/A	Painted X Walk1?	No	N/A	Painted X Walk2?	N/A
						X Walk 1 Direction	To E		X Walk 2 Direction	N/A
	· ""				N/A	X Walk 1 Width (in)	N/A	N/A	X Walk 2 Width (in)	N/A
Street 1 Name	ROOK RD					X Walk 1 Slope (%)	2.4		X Walk 2 Slope (%)	N/A
Stop Condition-Street 2	None					X Walk 1 X Slope (%)	1.7		X Walk 2 X Slope (%)	N/A
Street 2 Name	N/A				N/A	Ramp inside XWalk1?	N/A	N/A	Ramp inside XWalk2?	N/A
Stop Condition-Street 1	N/A					Road Slope (%)	N/A	N/A	Clear Space?	N/A
						Road X Slope (%)	N/A	N/A	Clear Space to XWalk (in)	N/A
					N/A	Any Obstructions?	N/A	N/A	Storm Grate/Utility Hazard?	N/A
	Total	Cost:	\$	1850.00		Obstruction Type			Storm Grate/Utility Type	
							N/A			N/A
								Yes	Surface Condition? (G/P)	Good
	i i i	100			M.	9
