Access Compliance Report

Public Rights-of-Way

(Curb Ramps)

Intersection ID: 12336	Main Street: CAMP_GREENE_ST	Cross Street: GREENLAND_AV	Location: NW
ADA ID: D05027D227E7	Ramp Type: PerpDiag	Initial Pass/Fail: Fail	Overall Compliance: No
Severity Score: 21.25			
Codes/Mitigation Info/Possible Solution		Field Measurements/Component Compliance

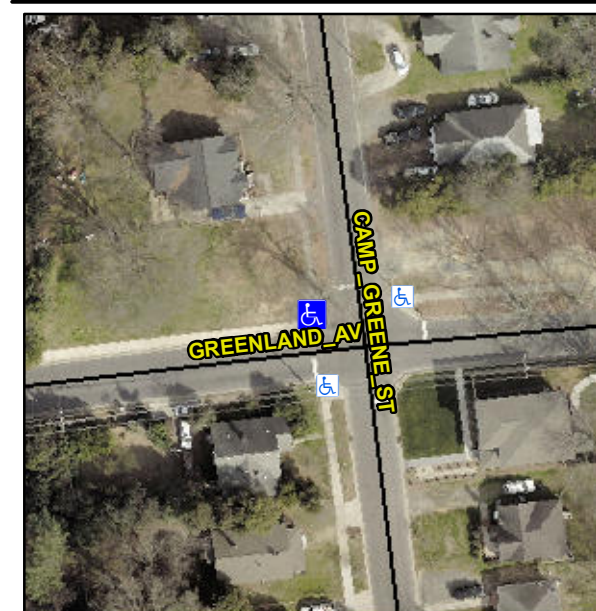
Not Found, R304.5.1, R304.2.2

Compliance	Description	Data	Compliance	Description	Data
N/A	Ramp Length (in)	60.0	No	Ramp Slope (%)	9.7
No	Ramp Width (in)	47.0	Yes	Ramp XSlope (%)	0.5
N/A	Flare Type LT	N/A	N/A	Flare Type RT	N/A
N/A	Flare Slope LT (%)	N/A	N/A	Flare Slope RT (%)	N/A
N/A	Flare Traversable LT?	N/A	N/A	Flare Traversable RT?	N/A
N/A	Landing Length (in)	N/A	N/A	DWS Provided?	N/A
N/A	Landing Width (in)	N/A	N/A	DWS Contrast?	N/A
N/A	Landing Slope (%)	N/A	N/A	DWS Length (in)	N/A
N/A	Landing X Slope (%)	N/A	N/A	DWS Full Width?	N/A
N/A	Landing Curb? (Y/N)	N/A	N/A	DWS Offset (in)	N/A
N/A	Shared Landing?	N/A			
N/A	Gutter Ponding?	N/A	N/A	Gutter Slope (%)	N/A
N/A	Gutter Lip Ht (in)	N/A	N/A	Gutter X Slope (%)	N/A
N/A	Painted X Walk1?	No	N/A	Painted X Walk2?	No
	X Walk 1 Direction	To S		X Walk 2 Direction	To E
N/A	X Walk 1 Width (in)	N/A	N/A	X Walk 2 Width (in)	N/A
	X Walk 1 Slope (%)	2.3		X Walk 2 Slope (%)	1.8
	X Walk 1 X Slope (%)	2.8		X Walk 2 X Slope (%)	0.8

N/A	Ramp inside XWalk1?	N/A	N/A	Ramp inside XWalk2?	N/A
	Road Slope (%)	0.5	N/A	Clear Space?	N/A
	Road X Slope (%)	2.5	N/A	Clear Space to XWalk (in)	N/A
N/A	Any Obstructions?	N/A	N/A	Storm Grate/Utility Hazard?	N/A
	Obstruction Type			Storm Grate/Utility Type	
		N/A			N/A
		Yes		Surface Condition? (G/P)	Good

Possible Solutions:

Remove & Replace Curb Ramp With Two New Directional Ramps or Equivalent.
