# Access Compliance Report

## Public Rights-of-Way

| Intersection ID: 47845 | Main Street: DEL_RIO_RD | Cross Street: CACTUS_VALLEY_RD | Location: SE |
| ADA ID: D057078C1ADC | Ramp Type: PerpDiag | Initial Pass/Fail: Fail | Overall Compliance: No |

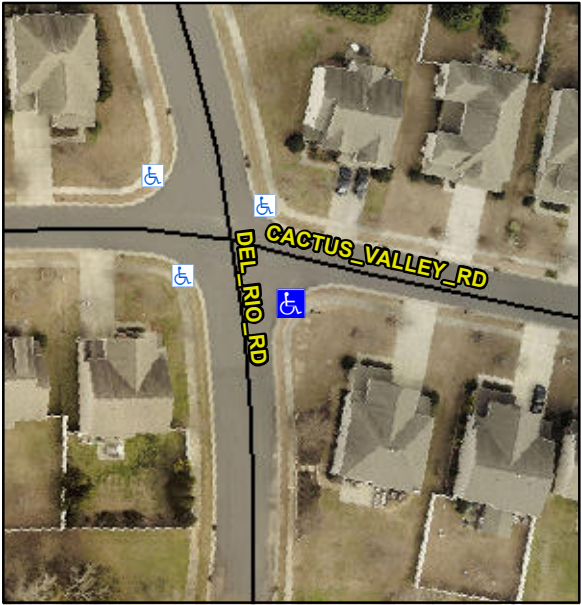
| Codes/Mitigation Info/Possible Solution | | | Field Measurements/Component Compliance | | |
|---|---|---|---|---|---|
| | <b>Remove &amp; Replace Curb Ramp With Two New Directional Ramps or Equivalent.</b> | | <b>No</b> | Ramp Length (in) | 47.0 |
| | | | <b>No</b> | Ramp Width (in) | 47.5 |
| <p>Surveyor Notes:</p> <p><b>N/A</b></p> <p>PROW/ADA:</p> <p><b>Not Found, R304.5.1, R304.2.2</b></p> | | | <b>N/A</b> | Flare Type RT | N/A |

| Codes/Mitigation Info/Possible Solution | | | Field Measurements/Component Compliance | | |
|---|---|---|---|---|---|
| Total Cost: | | \$ 3200.00 | | | |
