Access Compliance Report

Public Rights-of-Way

(Curb Ramps)

Intersection ID: 14600	Main Street: DILWORTH_RD	Cross Street: DILWORTH_RD_EAST	Location: W
ADA ID: D05D1A673F49	Ramp Type: PerpDiag	Initial Pass/Fail: Fail	Overall Compliance: No
Severity Score: 8.75			
Codes/Mitigation Info/Possible Solution		Field Measurements/Component Compliance

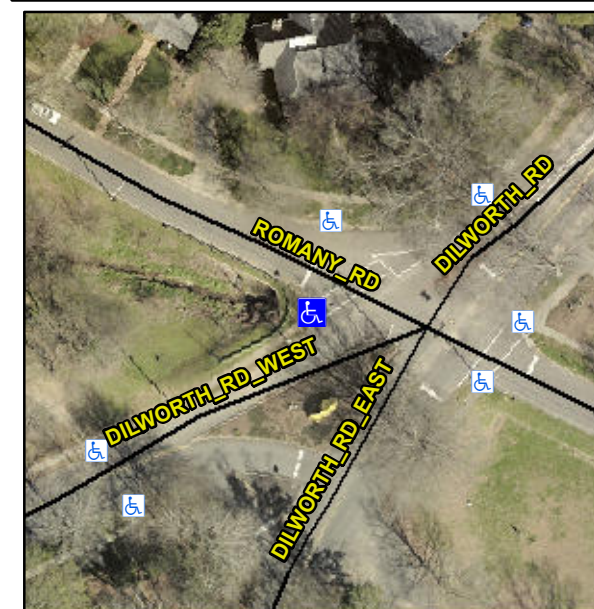
Not Found, R304.5.1

Compliance	Description	Data	Compliance	Description	Data
N/A	Ramp Length (in)	63.0	Yes	Ramp Slope (%)	8.2
No	Ramp Width (in)	47.0	Yes	Ramp XSlope (%)	1.4
N/A	Flare Type LT	N/A	N/A	Flare Type RT	N/A
N/A	Flare Slope LT (%)	N/A	N/A	Flare Slope RT (%)	N/A
N/A	Flare Traversable LT?	N/A	N/A	Flare Traversable RT?	N/A
N/A	Landing Length (in)	N/A	N/A	DWS Provided?	N/A
N/A	Landing Width (in)	N/A	N/A	DWS Contrast?	N/A
N/A	Landing Slope (%)	N/A	N/A	DWS Length (in)	N/A
N/A	Landing X Slope (%)	N/A	N/A	DWS Full Width?	N/A
N/A	Landing Curb? (Y/N)	N/A	N/A	DWS Offset (in)	N/A
N/A	Shared Landing?	N/A			
N/A	Gutter Ponding?	N/A	N/A	Gutter Slope (%)	N/A
N/A	Gutter Lip Ht (in)	1.0	N/A	Gutter X Slope (%)	N/A
N/A	Painted X Walk1?	No	N/A	Painted X Walk2?	Yes
	X Walk 1 Direction	To SE		X Walk 2 Direction	To NE
N/A	X Walk 1 Width (in)	N/A	N/A	X Walk 2 Width (in)	99.0
	X Walk 1 Slope (%)	2.3		X Walk 2 Slope (%)	1.9
	X Walk 1 X Slope (%)	0.2		X Walk 2 X Slope (%)	1.4

N/A	Ramp inside XWalk1?	N/A	N/A	Ramp inside XWalk2?	Yes
	Road Slope (%)	2.9	N/A	Clear Space?	N/A
	Road X Slope (%)	3.5	N/A	Clear Space to XWalk (in)	N/A
N/A	Any Obstructions?	N/A	N/A	Storm Grate/Utility Hazard?	N/A
	Obstruction Type			Storm Grate/Utility Type	
		N/A			N/A
		Yes		Surface Condition? (G/P)	Good

Possible Solutions:

Remove & Replace Curb Ramp With Two New Directional Ramps or Equivalent.
