Access Compliance Report

Public Rights-of-Way

(Curb Ramps)

Intersection ID: 13946	Main Street: DILWORTH_RD	Cross Street: E_MOREHEAD_ST	Location: S
ADA ID: D06156AA1115	Ramp Type: Directional1	Initial Pass/Fail: Fail	Overall Compliance: No
		Severity Score: 37.5

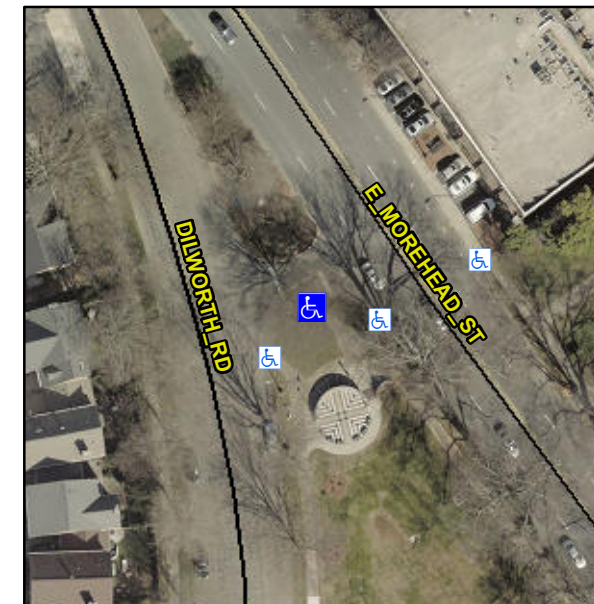
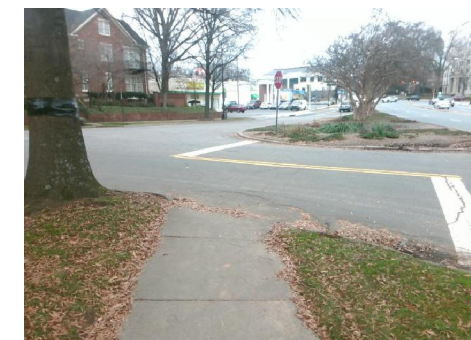
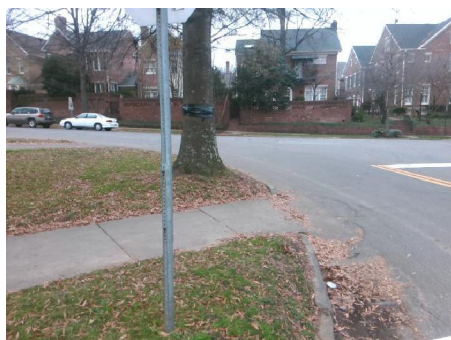
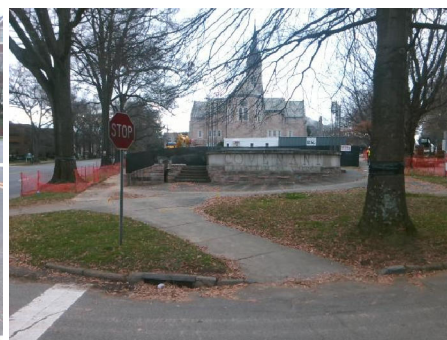
R304.2.2, R304.5.3

Compliance	Description	Data	Compliance	Description	Data
N/A	Ramp Length (in)	36.0	N/A	Grade Break?	N/A
Yes	Ramp Width (in)	60.0	N/A	Grade Break Slope (%)	0.0
No	Ramp Slope (%)	8.9	N/A	Grade Break XSlope (%)	0.0
No	Ramp XSlope (%)	10.8			
N/A	Flare Type LT	N/A	N/A	Flare Type RT	N/A
N/A	Flare Slope LT (%)	N/A	N/A	Flare Slope RT (%)	0.0
N/A	Flare Traversable LT?	N/A	N/A	Flare Traversable RT?	N/A
N/A	Landing Length (in)	0.0	N/A	DWS Provided?	N/A
N/A	Landing Width (in)	0.0	N/A	DWS Contrast?	N/A
N/A	Landing Slope (%)	0.0	N/A	DWS Length (in)	N/A
N/A	Landing X Slope (%)	0.0	N/A	DWS Full Width?	N/A
N/A	Landing Curb? (Y/N)	N/A	N/A	DWS Offset LT (in)	N/A
N/A	Shared Landing?	N/A	N/A	DWS Offset RT (in)	N/A
N/A	Gutter Ponding?	0.0	N/A	Gutter Slope (%)	N/A
N/A	Gutter Lip Ht (in)	0.0	N/A	Gutter X Slope (%)	N/A
N/A	Painted X Walk1?	No		Road Slope (%)	6.0
	X Walk 1 Direction	To N		Road X Slope (%)	2.8
	X Walk 1 Width (in)	N/A		Clear Space?	N/A

X Walk 1 Slope (%)	6.0	N/A	Clear Space to XWalk (in)	N/A
	X Walk 1 X Slope (%)	2.8	N/A	Storm Grate/Utility Hazard?	N/A
N/A	Ramp inside XWalk1?	N/A		Storm Grate/Utility Type	
N/A	Any Obstructions?	N/A			N/A
	Obstruction Type		Yes	Surface Condition? (G/P)	Good
			N/A	Curb Slope (%)	9.5

Possible Solutions:

Remove & Replace Entire Ramp.
