Access Compliance Report

Public Rights-of-Way

(Curb Ramps)

Intersection ID: 11598	Main Street: SCARLET_SAGE_DR	Cross Street: VERONICA_DR	Location: SE
ADA ID: D074E6C683F3	Ramp Type: Perp	Initial Pass/Fail: Fail	Overall Compliance: No
		Severity Score: 22.5

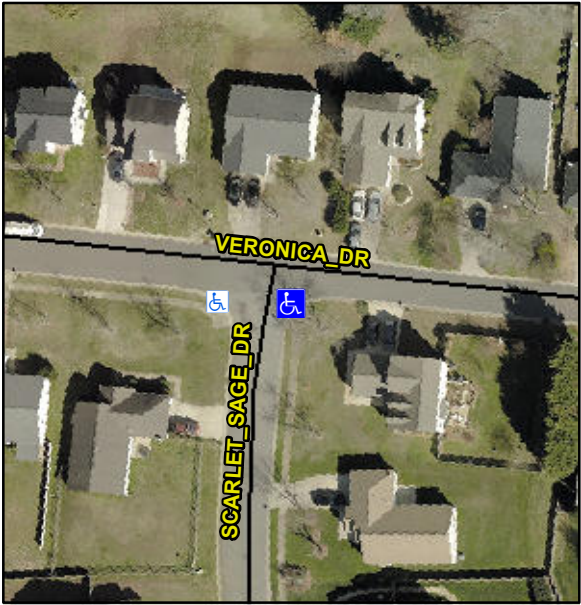
Possible Solutions:		Compliance	Description	Data
	Remove & Replace Entire Ramp.		N/A	Ramp Length (in)	51.0
			No	Ramp Width (in)	38.0
			N/A	Flare Type LT	N/A
			N/A	Flare Slope LT (%)	N/A
			N/A	Flare Traversable LT?	N/A
			N/A	Landing Length (in)	N/A
			N/A	Landing Width (in)	N/A
			N/A	Landing Slope (%)	N/A
			N/A	Landing X Slope (%)	N/A
<p>Surveyor Notes:</p> <p>N/A</p> <p>PROW/ADA:</p> <p>Not Found, R304.5.1, R304.2.2, R304.5.3</p>			N/A	Flare Type RT	N/A
			N/A	Flare Slope RT (%)	N/A
			N/A	Flare Traversable RT?	N/A
			N/A	DWS Provided?	N/A
			N/A	DWS Contrast?	N/A
			N/A	DWS Length (in)	N/A
			N/A	DWS Full Width?	N/A
			N/A	DWS Offset (in)	N/A
			N/A	Shared Landing?	N/A
			N/A	Gutter Ponding?	N/A
			N/A	Gutter Lip Ht (in)	N/A
			N/A	Painted X Walk1?	No
				X Walk 1 Direction	To W
			N/A	X Walk 1 Width (in)	N/A
				X Walk 1 Slope (%)	5.8

X Walk 1 X Slope (%)	0.4
			N/A	Ramp inside XWalk1?	N/A
			N/A	Road Slope (%)	N/A
			N/A	Road X Slope (%)	N/A
			N/A	Any Obstructions?	N/A
				Obstruction Type	
			N/A		N/A
			Yes	Surface Condition? (G/P)	Good
