Access Compliance Report

Public Rights-of-Way

(Curb Ramps)

Intersection ID: 14830	Main Street: ALBERTO_ST	Cross Street: CRESCENT_AV	Location: NW
ADA ID: D07D1852A302	Ramp Type: Perp	Initial Pass/Fail: Fail	Overall Compliance: No
		Severity Score: 12.5

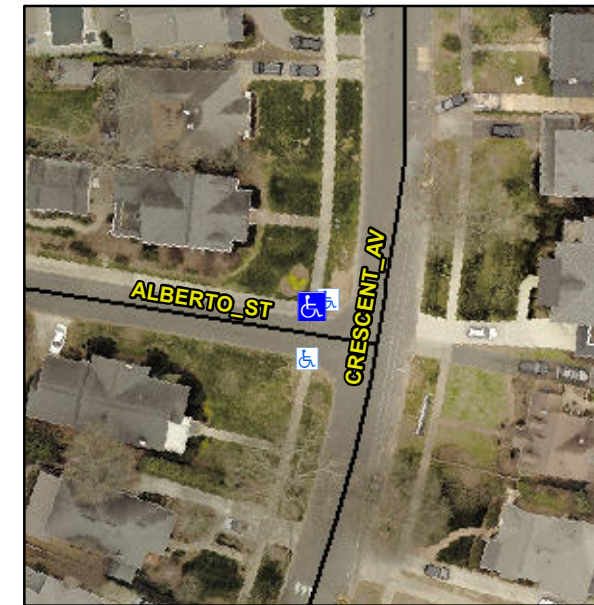
Compliance	Description	Data	Compliance	Description	Data
N/A	Ramp Length (in)	58.0	No	Ramp Slope (%)	8.8
Yes	Ramp Width (in)	72.0	Yes	Ramp XSlope (%)	0.8
N/A	Flare Type LT	N/A	N/A	Flare Type RT	N/A
N/A	Flare Slope LT (%)	N/A	N/A	Flare Slope RT (%)	N/A
N/A	Flare Traversable LT?	N/A	N/A	Flare Traversable RT?	N/A
N/A	Landing Length (in)	N/A	N/A	DWS Provided?	N/A
N/A	Landing Width (in)	N/A	N/A	DWS Contrast?	N/A
N/A	Landing Slope (%)	N/A	N/A	DWS Length (in)	N/A
N/A	Landing X Slope (%)	N/A	N/A	DWS Full Width?	N/A
N/A	Landing Curb? (Y/N)	N/A	N/A	DWS Offset (in)	N/A
N/A	Shared Landing?	N/A			
N/A	Gutter Ponding?	N/A	N/A	Gutter Slope (%)	N/A
N/A	Gutter Lip Ht (in)	N/A	N/A	Gutter X Slope (%)	N/A
N/A	Painted X Walk1?	No	N/A	Painted X Walk2?	N/A
	X Walk 1 Direction	To SW		X Walk 2 Direction	N/A
N/A	X Walk 1 Width (in)	N/A	N/A	X Walk 2 Width (in)	N/A
	X Walk 1 Slope (%)	2.0		X Walk 2 Slope (%)	N/A
	X Walk 1 X Slope (%)	0.5		X Walk 2 X Slope (%)	N/A

N/A	Ramp inside XWalk1?	N/A	N/A	Ramp inside XWalk2?	N/A
	Road Slope (%)	N/A	N/A	Clear Space?	N/A
	Road X Slope (%)	N/A	N/A	Clear Space to XWalk (in)	N/A
N/A	Any Obstructions?	N/A	N/A	Storm Grate/Utility Hazard?	N/A
	Obstruction Type			Storm Grate/Utility Type	
		N/A			N/A
		Yes		Surface Condition? (G/P)	Good

Remove & Replace Entire Ramp.

R304.2.2
