# Access Compliance Report

## Public Rights-of-Way

### (Curb Ramps)

Intersection ID: 14747	Main Street: EASTWAY_DR	Cross Street: GOODWIN_AV	Location: NW
ADA ID: D07DD5FC3E6C	Ramp Type: Directional1	Initial Pass/Fail: Fail	Overall Compliance: No
			Severity Score: 13.75

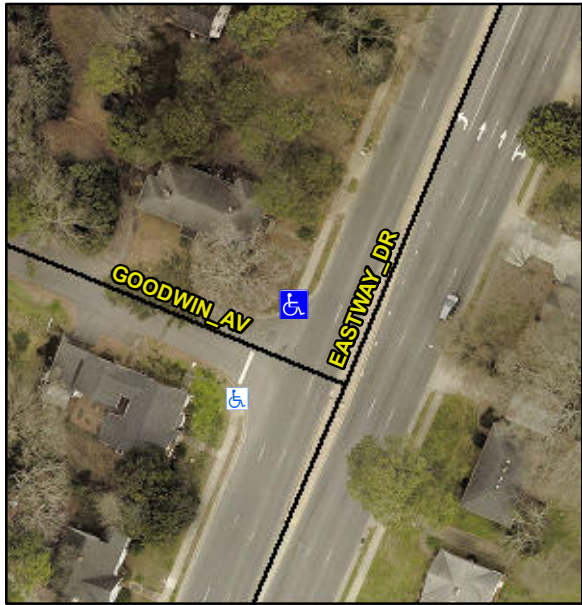
<div>Street 1 Name<div>GOODWIN AV</div></div> <div>Stop Condition-Street 1<div>StopSign</div></div> <div>Street 2 Name<div>N/A</div></div> <div>Stop Condition-Street 2<div>N/A</div></div>	Possible Solutions:		Compliance			Compliance		
	Remove & Replace Entire Ramp.		Description			Data		
			N/A	Ramp Length (in)	41.0	N/A	Grade Break?	N/A
			Yes	Ramp Width (in)	48.0	N/A	Grade Break Slope (%)	0.0
			No	Ramp Slope (%)	8.4	N/A	Grade Break XSlope (%)	0.0
			No	Ramp XSlope (%)	4.8			
			N/A	Flare Type LT	N/A	N/A	Flare Type RT	N/A
			N/A	Flare Slope LT (%)	N/A	N/A	Flare Slope RT (%)	0.0
	Surveyor Notes:		N/A	Flare Traversable LT?	N/A	N/A	Flare Traversable RT?	N/A
	N/A		N/A	Landing Length (in)	0.0	N/A	DWS Provided?	N/A
			N/A	Landing Width (in)	0.0	N/A	DWS Contrast?	N/A
			N/A	Landing Slope (%)	0.0	N/A	DWS Length (in)	N/A

N/A	Landing X Slope (%)	0.0	N/A	DWS Full Width?	N/A
	PROW/ADA:		N/A	Landing Curb? (Y/N)	N/A	N/A	DWS Offset LT (in)	N/A
	R304.2.2, R304.5.3		N/A	Shared Landing?	N/A	N/A	DWS Offset RT (in)	N/A
			N/A	Gutter Ponding?	0.0	N/A	Gutter Slope (%)	N/A
			N/A	Gutter Lip Ht (in)	0.0	N/A	Gutter X Slope (%)	N/A
			N/A	Painted X Walk1?	No		Road Slope (%)	0.2
				X Walk 1 Direction	To S		Road X Slope (%)	5.1
				X Walk 1 Width (in)	N/A		Clear Space?	N/A
				X Walk 1 Slope (%)	0.2	N/A	Clear Space to XWalk (in)	N/A
				X Walk 1 X Slope (%)	5.1	N/A	Storm Grate/Utility Hazard?	N/A
			N/A	Ramp inside XWalk1?	N/A		Storm Grate/Utility Type	
			N/A	Any Obstructions?	N/A			N/A
				Obstruction Type		Yes	Surface Condition? (G/P)	Good
					N/A	Curb Slope (%)	19.7	
Total Cost:		\$ 1600.00
