Access Compliance Report

Public Rights-of-Way

(Curb Ramps)

Intersection ID: 45183	Main Street: WESTON_GLEN_DR	Cross Street: COMMUNITY_HOUSE_RD	Location: NE
ADA ID: D0872D3F0B8F	Ramp Type: PerpDiag	Initial Pass/Fail: Fail	Overall Compliance: No
Severity Score: 8.75			
Codes/Mitigation Info/Possible Solution		Field Measurements/Component Compliance

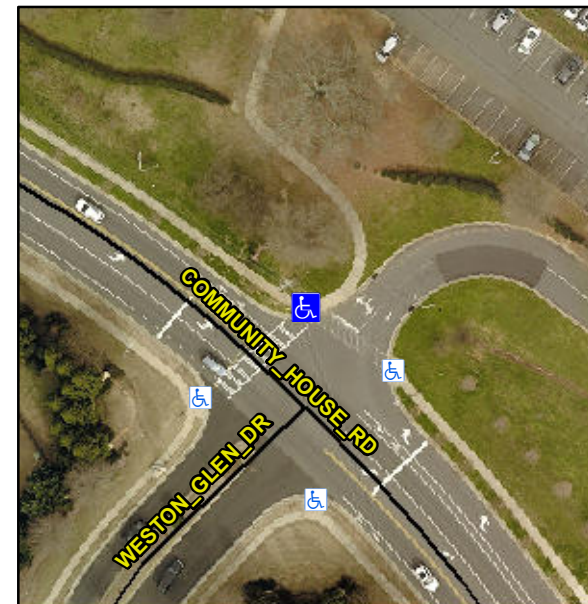
Not Found, R304.5.1

Compliance	Description	Data	Compliance	Description	Data
N/A	Ramp Length (in)	72.0	Yes	Ramp Slope (%)	7.0
No	Ramp Width (in)	41.5	Yes	Ramp XSlope (%)	0.9
N/A	Flare Type LT	N/A	N/A	Flare Type RT	N/A
N/A	Flare Slope LT (%)	N/A	N/A	Flare Slope RT (%)	N/A
N/A	Flare Traversable LT?	N/A	N/A	Flare Traversable RT?	N/A
N/A	Landing Length (in)	N/A	N/A	DWS Provided?	N/A
N/A	Landing Width (in)	N/A	N/A	DWS Contrast?	N/A
N/A	Landing Slope (%)	N/A	N/A	DWS Length (in)	N/A
N/A	Landing X Slope (%)	N/A	N/A	DWS Full Width?	N/A
N/A	Landing Curb? (Y/N)	N/A	N/A	DWS Offset (in)	N/A
N/A	Shared Landing?	N/A			
N/A	Gutter Ponding?	N/A	N/A	Gutter Slope (%)	N/A
N/A	Gutter Lip Ht (in)	N/A	N/A	Gutter X Slope (%)	N/A
N/A	Painted X Walk1?	Yes	N/A	Painted X Walk2?	Yes
	X Walk 1 Direction	To SW		X Walk 2 Direction	To SE
N/A	X Walk 1 Width (in)	112.0	N/A	X Walk 2 Width (in)	72.0
	X Walk 1 Slope (%)	3.0		X Walk 2 Slope (%)	0.4
	X Walk 1 X Slope (%)	1.4		X Walk 2 X Slope (%)	1.4

N/A	Ramp inside XWalk1?	Yes	N/A	Ramp inside XWalk2?	No
	Road Slope (%)	1.7	N/A	Clear Space?	N/A
	Road X Slope (%)	2.6	N/A	Clear Space to XWalk (in)	N/A
N/A	Any Obstructions?	N/A	N/A	Storm Grate/Utility Hazard?	N/A
	Obstruction Type			Storm Grate/Utility Type	
		N/A			N/A
		Yes		Surface Condition? (G/P)	Good

Remove & Replace Curb Ramp With Two New Directional Ramps or Equivalent. Restripe Crosswalk.
