Access Compliance Report

Public Rights-of-Way

(Curb Ramps)

Intersection ID: 5912	Main Street: BLACK_CHERRY_DR	Cross Street: FOREST_POND_DR	Location: SE
ADA ID: D08C10240F28	Ramp Type: Perp	Initial Pass/Fail: Fail	Overall Compliance: No
Severity Score: 21.25			
Codes/Mitigation Info/Possible Solution		Field Measurements/Component Compliance

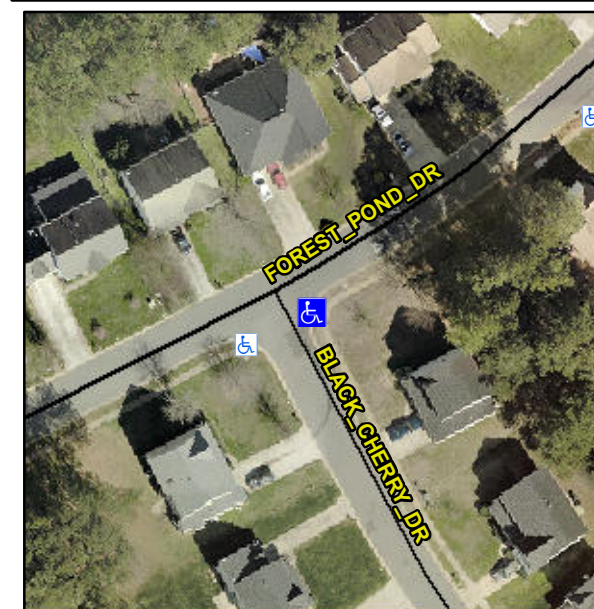
Not Found, R304.5.1, R304.5.3

Compliance	Description	Data	Compliance	Description	Data
N/A	Ramp Length (in)	96.0	Yes	Ramp Slope (%)	6.8
No	Ramp Width (in)	45.0	No	Ramp XSlope (%)	6.6
N/A	Flare Type LT	N/A	N/A	Flare Type RT	N/A
N/A	Flare Slope LT (%)	N/A	N/A	Flare Slope RT (%)	N/A
N/A	Flare Traversable LT?	N/A	N/A	Flare Traversable RT?	N/A
N/A	Landing Length (in)	N/A	N/A	DWS Provided?	N/A
N/A	Landing Width (in)	N/A	N/A	DWS Contrast?	N/A
N/A	Landing Slope (%)	N/A	N/A	DWS Length (in)	N/A
N/A	Landing X Slope (%)	N/A	N/A	DWS Full Width?	N/A
N/A	Landing Curb? (Y/N)	N/A	N/A	DWS Offset (in)	N/A
N/A	Shared Landing?	N/A			
N/A	Gutter Ponding?	N/A	N/A	Gutter Slope (%)	N/A
N/A	Gutter Lip Ht (in)	N/A	N/A	Gutter X Slope (%)	N/A
N/A	Painted X Walk1?	No	N/A	Painted X Walk2?	N/A
	X Walk 1 Direction	To W		X Walk 2 Direction	N/A
N/A	X Walk 1 Width (in)	N/A	N/A	X Walk 2 Width (in)	N/A
	X Walk 1 Slope (%)	0.1		X Walk 2 Slope (%)	N/A
	X Walk 1 X Slope (%)	6.2		X Walk 2 X Slope (%)	N/A

N/A	Ramp inside XWalk1?	N/A	N/A	Ramp inside XWalk2?	N/A
	Road Slope (%)	N/A	N/A	Clear Space?	N/A
	Road X Slope (%)	N/A	N/A	Clear Space to XWalk (in)	N/A
N/A	Any Obstructions?	N/A	N/A	Storm Grate/Utility Hazard?	N/A
	Obstruction Type			Storm Grate/Utility Type	
		N/A			N/A
			Yes	Surface Condition? (G/P)	Good

Remove & Replace Entire Ramp.
