Access Compliance Report

Public Rights-of-Way

(Curb Ramps)

Intersection ID: 21326		Main Street: PROVIDENCE_RD		Cross Street: TURNBRIDGE_RD		Location: NW															
ADA ID: D099CA9A7A20		Ramp Type: Directional1		Initial Pass/Fail: Fail		Overall Compliance: No		Severity Score: 1.25													
Codes/Mitigation Info/Possible Solution				Field Measurements/Component Compliance																	
<div>

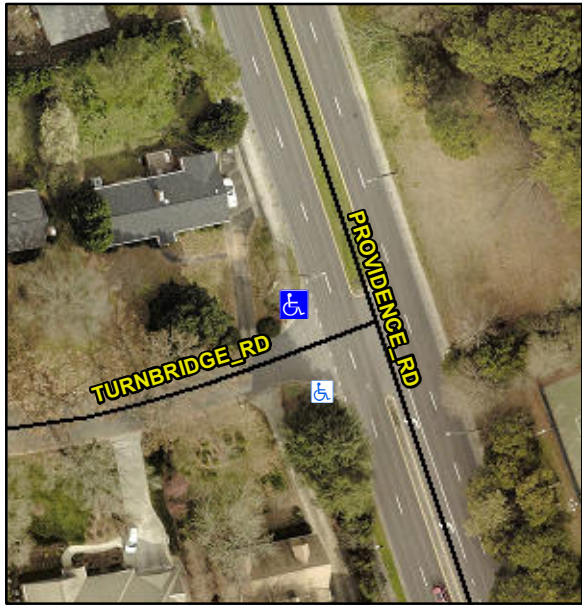
</div> <div>Street 1 NameTURNBRIDGE RD</div> <div>Stop Condition-Street 1StopSign</div> <div>Street 2 NameN/A</div> <div>Stop Condition-Street 2N/A</div>				Possible Solutions:		Compliance		Description		Data		Compliance		Description		Data					
				Remove & Replace Entire Ramp.		N/A		Ramp Length (in)		59.5		N/A		Grade Break?		N/A		N/A			
						Yes		Ramp Width (in)		70.0		N/A		Grade Break Slope (%)		0.0		0.0			
						Yes		Ramp Slope (%)		5.1		N/A		Grade Break XSlope (%)		0.0		0.0			
						No		Ramp XSlope (%)		4.2											
						N/A		Flare Type LT		N/A		N/A		Flare Type RT		N/A		N/A

N/A		Flare Slope LT (%)		N/A		N/A		Flare Slope RT (%)		0.0		0.0			
				Surveyor Notes:		N/A		N/A		Flare Traversable LT?		N/A		N/A		Flare Traversable RT?		N/A		N/A	
						N/A		N/A		Landing Length (in)		0.0		N/A		DWS Provided?		N/A		N/A	
						N/A		N/A		Landing Width (in)		0.0		N/A		DWS Contrast?		N/A		N/A	
						N/A		N/A		Landing Slope (%)		0.0		N/A		DWS Length (in)		N/A		N/A	
						N/A		N/A		Landing X Slope (%)		0.0		N/A		DWS Full Width?		N/A		N/A	
				PROW/ADA:		N/A		N/A		Landing Curb? (Y/N)		N/A		N/A		DWS Offset LT (in)		N/A		N/A	
				R304.5.3		N/A		N/A		Shared Landing?		N/A		N/A		DWS Offset RT (in)		N/A		N/A	
						N/A		N/A		Gutter Ponding?		0.0		N/A		Gutter Slope (%)		N/A		N/A	
						N/A		N/A		Gutter Lip Ht (in)		0.0		N/A		Gutter X Slope (%)		N/A		N/A	
						N/A		N/A		Painted X Walk1?		No				Road Slope (%)		1.1		1.1	
										X Walk 1 Direction		To S				Road X Slope (%)		1.2		1.2	
										X Walk 1 Width (in)		N/A				Clear Space?		N/A		N/A

X Walk 1 Slope (%)		1.1		N/A		Clear Space to XWalk (in)		N/A		N/A	
										X Walk 1 X Slope (%)		1.2		N/A		Storm Grate/Utility Hazard?		N/A		N/A	
				N/A		Ramp inside XWalk1?		N/A				Storm Grate/Utility Type									
				N/A		Any Obstructions?		N/A								N/A					
						Obstruction Type				Yes		Surface Condition? (G/P)		Good		Good					
								N/A		N/A		Curb Slope (%)		5.2		5.2					
				Total Cost:		\$		1600.00
