# Access Compliance Report

## Public Rights-of-Way

### (Curb Ramps)

Intersection ID: 50446	Main Street: HAWFIELD_WOODS_LN	Cross Street: ALICE_MCGINN_DR	Location: SE
ADA ID: D0A1E2B71BD0	Ramp Type: BlendTrans1	Initial Pass/Fail: Fail	Overall Compliance: No
Severity Score: 1.25			
Codes/Mitigation Info/Possible Solution		Field Measurements/Component Compliance

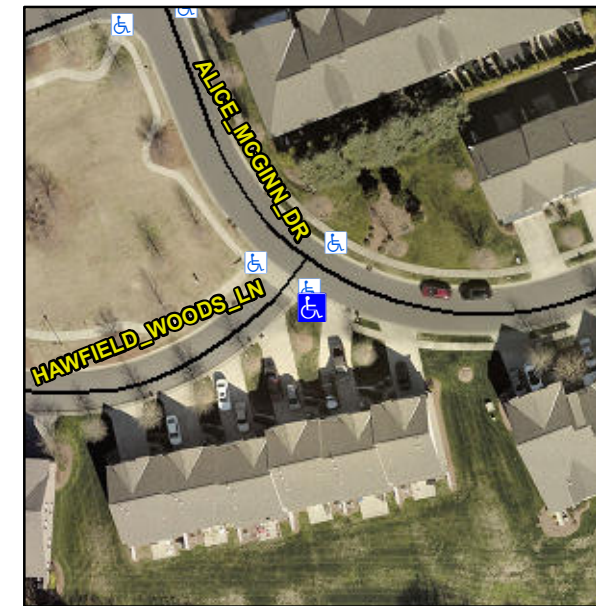
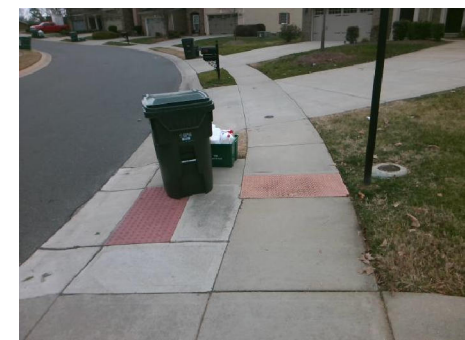
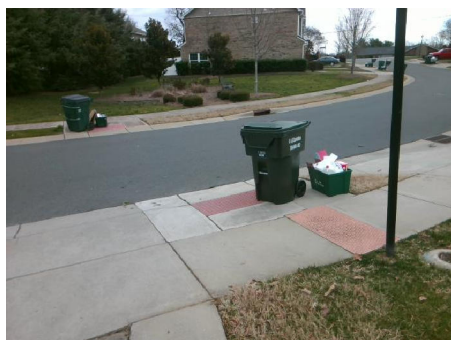
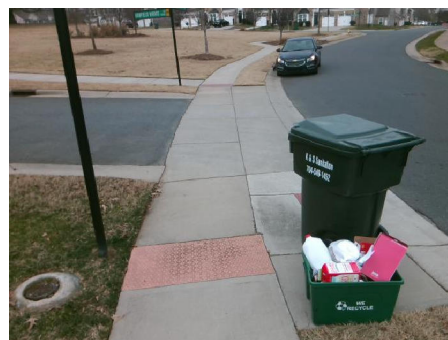
Compliance	Description	Data	Compliance	Description	Data
N/A	Ramp Length (in)	65.0	Yes	BlendTrans Slope (%)	3.8
Yes	Ramp Width (in)	48.0	No	BlendTrans XSlope (%)	2.3
N/A	Flare Type LT	N/A	N/A	Flare Type RT	N/A
N/A	Flare Slope LT (%)	N/A	N/A	Flare Slope RT (%)	N/A
N/A	Flare Traversable LT?	N/A	N/A	Flare Traversable RT?	N/A
N/A	Landing Length (in)	N/A	N/A	DWS Provided?	N/A
N/A	Landing Width (in)	N/A	N/A	DWS Contrast?	N/A
N/A	Landing Slope (%)	N/A	N/A	DWS Length (in)	N/A
N/A	Landing X Slope (%)	N/A	N/A	DWS Full Width?	N/A
N/A	Landing Curb? (Y/N)	N/A	N/A	DWS Offset (in)	N/A
N/A	Shared Landing?	N/A			
N/A	Gutter Ponding?	N/A	N/A	Gutter Slope (%)	N/A
N/A	Gutter Lip Ht (in)	N/A	N/A	Gutter X Slope (%)	N/A
N/A	Painted X Walk1?	No	N/A	Painted X Walk2?	N/A
	X Walk 1 Direction	To NW		X Walk 2 Direction	N/A
	X Walk 1 Width (in)	N/A		X Walk 2 Width (in)	N/A
	X Walk 1 Slope (%)	3.4		X Walk 2 Slope (%)	N/A
	X Walk 1 X Slope (%)	2.6		X Walk 2 X Slope (%)	N/A

N/A	Ramp inside XWalk1?	N/A	N/A	Ramp inside XWalk2?	N/A
	Road Slope (%)	2.6		Clear Space?	N/A
	Road X Slope (%)	3.4	N/A	Clear Space to XWalk (in)	N/A
N/A	Any Obstructions?	N/A	N/A	Storm Grate/Utility Hazard?	N/A
	Obstruction Type			Storm Grate/Utility Type	
		N/A			N/A
			Yes	Surface Condition? (G/P)	Good
			N/A	Curb Slope (%)	1.8

**Remove & Replace Curb Ramp With Two New Directional Ramps or Equivalent.**

**R304.5.3**
